**Investigation of Approach Slab Construction and Evaluation of Modular Approach
Slab Designs**

Final Report

**University of Illinois at Urbana-Champaign
Department of Civil and Environmental Engineering
January 2021**

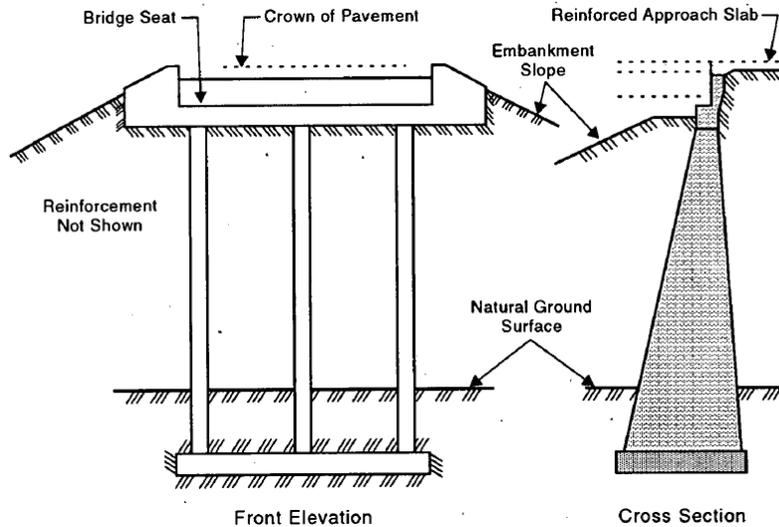
Figure 1.2 Typical spill-through abutment supported on columns (Briaud et al. 1997).

Open abutments have also been referred to as pile bent or spill through abutments (IDOT 2012). Such abutments generally have less height of wall compared to closed abutments. If an open abutment is designed in an old fashion, supported on columns as seen in Figure 1.2, it must be constructed before the embankment. It is challenging to compact the embankment fill between the columns. However, if the abutments become so-called “stub type”, they can be supported on shallow foundations or piles, which makes it possible to be constructed after the embankment is filled up to the height corresponding to the bottom of the abutment. As a result, the compaction of embankment fill is simplified (Briaud et al. 1997).

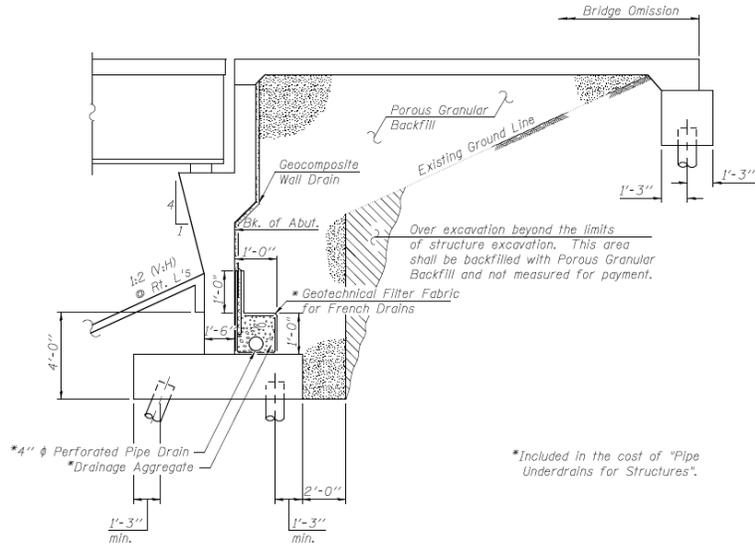
Figure 1.3 Typical section through filled vaulted abutment (IDOT 2012).

Vaulted abutments include filled and unfilled. The standard vaulted abutment in Illinois uses precast, prestressed beams to support the abutment span, as illustrated in Figure 1.3. This type of abutment is used when the abutment design span at right angles is larger than 6.4 m (21 ft). Similar to closed abutments, vaulted abutments are not allowed by the Illinois Tollway (2019) for new or replacement structures unless specifically authorized.

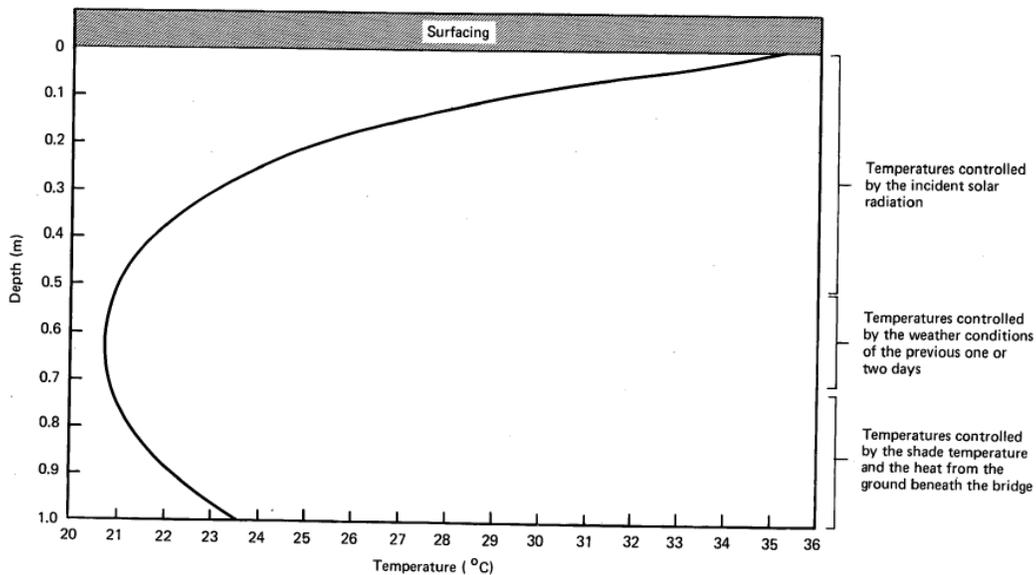
Figure 2.5 Temperature distribution of a bridge superstructure and controlling environmental conditions (Emerson 1977).

Emerson (1977) estimated the temperature distribution through the depth of concrete bridge decks and the concrete deck slabs of composite bridge based on empirical methods as well as field data. The study suggested that temperature differences will always exist in the deck slabs except during prolonged periods of overcast or during wet weather. The temperature distribution is attributable to the type of construction, the time of day, the time of year, the section depth, surfacing, and possibly the weather conditions of the previous one or two days for concrete structures. Figure 2.5 illustrates how the environmental factors affect the temperature distribution.

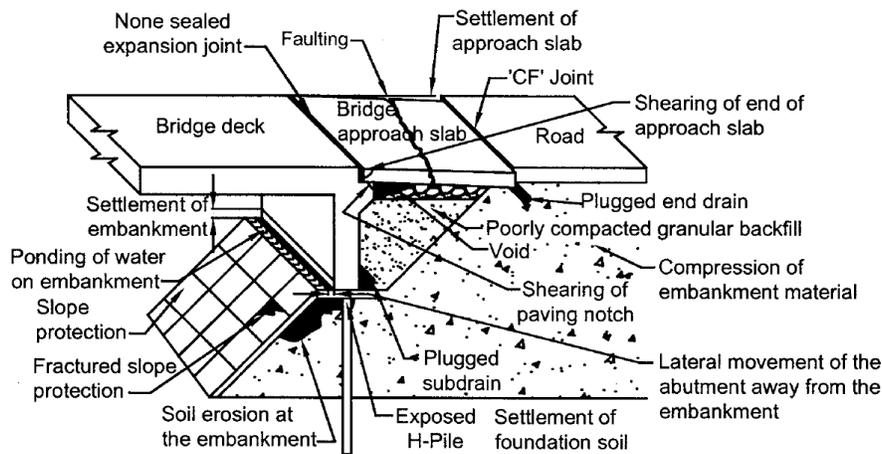
Figure 2.6 Frequent problems with approach system in Iowa (White et al. 2007).

White et al. (2007) summarized the frequent problems of approach systems observed at bridge sites in Iowa, as shown in Figure 2.6. The field study included 74 bridges in Iowa. At 25% of the bridges, thirteen of which were IABs, severe void development problems were observed. It was found that void development commonly occurs within one year of bridge approach slab construction. Severe soil erosion under the approach slab and around the bridge was observed at about 40% of the 74 bridges, fourteen of which were IABs (White et al. 2007).

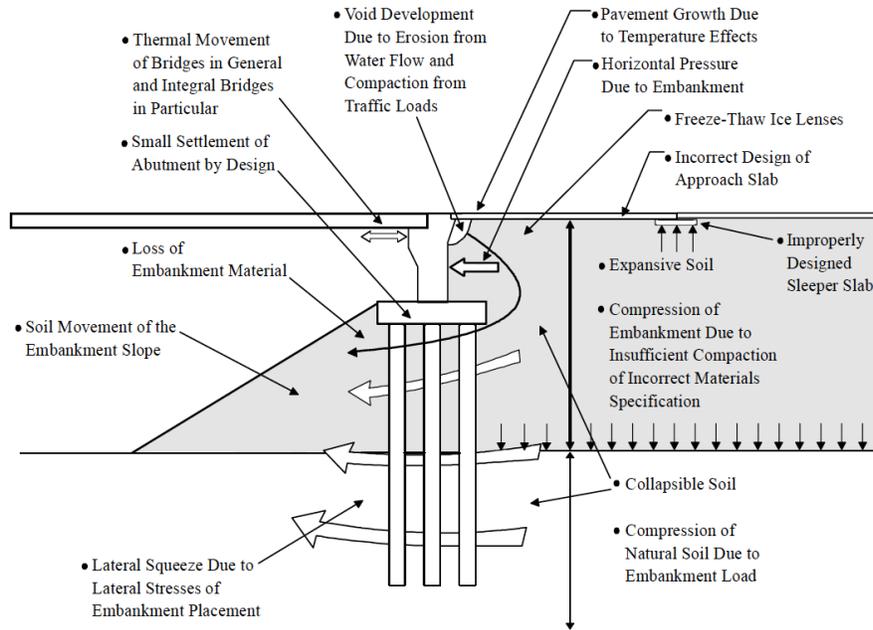
Figure 2.7 Factors that may contribute to the bump problem (Briaud et al. 1997).

Figure 2.7 also summarizes the factors that may contribute to the bump problem (Briaud et al. 1997).

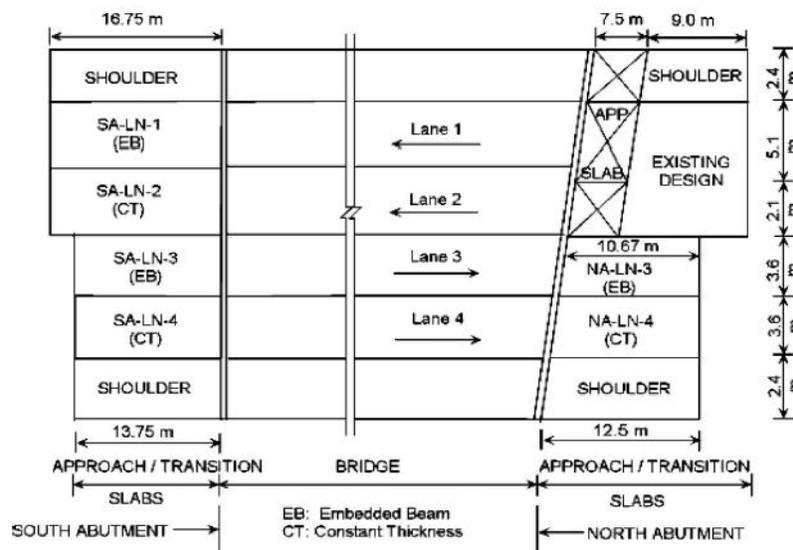
Figure 2.8 Layout of approach slabs on the bridge under investigation (Nassif et al. 2007).

Researchers at Rutgers University (Nassif et al. 2007) instrumented six approach slabs on the Doremus Avenue Bridge in Newark, New Jersey, and tested them prior to opening to traffic. The research aimed to recommend new design details based on static testing and long-term monitoring of approach slabs. The layout of the approach slabs at the Doremus Avenue Bridge is shown in Figure 2.8. The slabs were constructed such that they have varying lengths to study the effect of length of the slab while the thickness was kept constant at 18 in. The slabs were instrumented with up to 20 sensors of various types: strain gauges, thermistors, dynamic strain gages, pressure cells, settlement sensors, and deformation sensors. The 96 channels of data were collected every hour with data loggers. The maximum and minimum values incurred during each hour were also recorded. More sensors were provided at critical sections identified by prior 3-D FE analysis (Nassif et al. 2002) and near the abutment, as it had been observed that most of the approach slab cracking takes places near abutments.

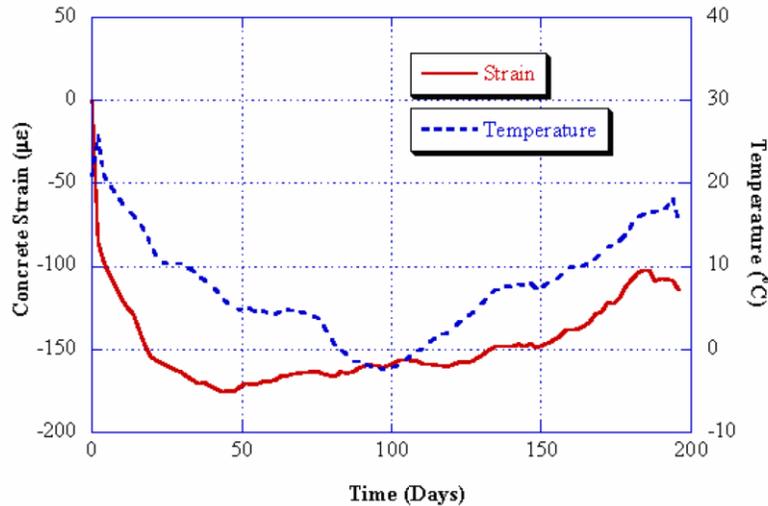
Figure 2.9 Approach slab strain and temperature profile with time (Nassif et al. 2007).

The study showed that the approach slab strains exhibit a sharp initial decrease that is not recovered afterward. This strain change is attributed to the shrinkage of concrete. However, after the initial strain change, subsequent strain changes are observed to be proportional to the temperature of the slab. Typical strain and temperature response histories are shown in Figure 2.9.

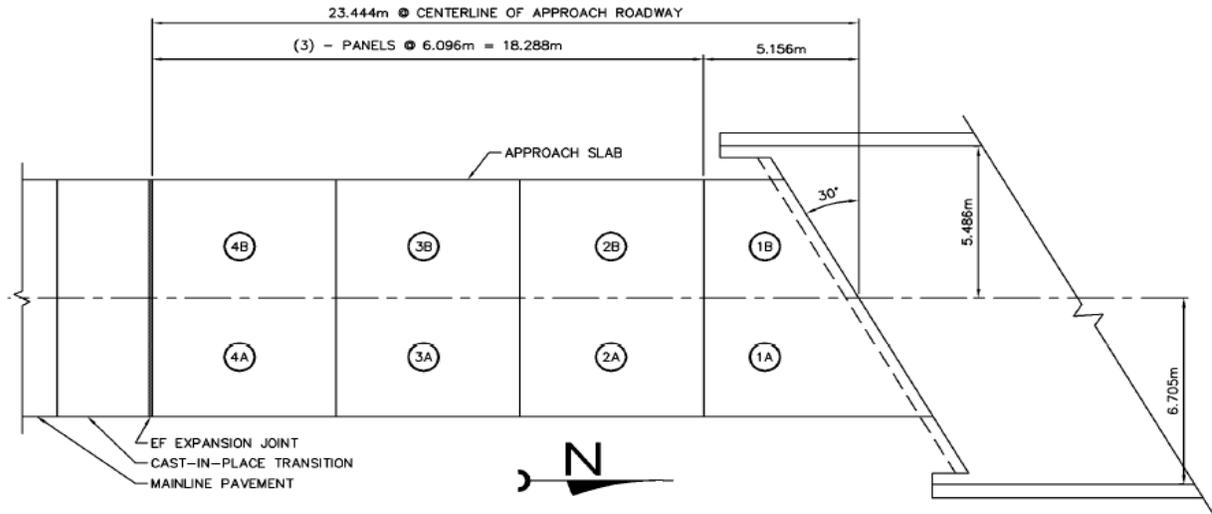
Figure 2.10 Plan view of northbound bridge precast approach slab (Greimann et al. 2008).

Researchers at Iowa State University instrumented two 3-span concrete girder bridges constructed in 2006 on the Iowa Highway 60 bypass in Sheldon, IA (Greimann et al. 2008). The objective of the study was to evaluate approach slab performance and the effects of connecting it integrally to the bridge. The northbound bridge has a 76 ft - 11 in. long precast approach slab, while the southbound bridge uses a 29 ft - 6 in. long cast-in-place approach slab. Both instrumented approach slabs have a 30° skew and 12 in. thickness. The support conditions for the two slabs differed significantly, with the precast slab supported continuously with a modified subbase used all along the bottom surface, while the cast-in-place slab is supported only at the ends, using a sleeper slab. The precast approach slab and cast-in-place approach slab are shown in Figures 2.10 and 2.11, respectively. Along with the approach slabs, other structural components, including the deck and piles, were also instrumented on the two bridges.

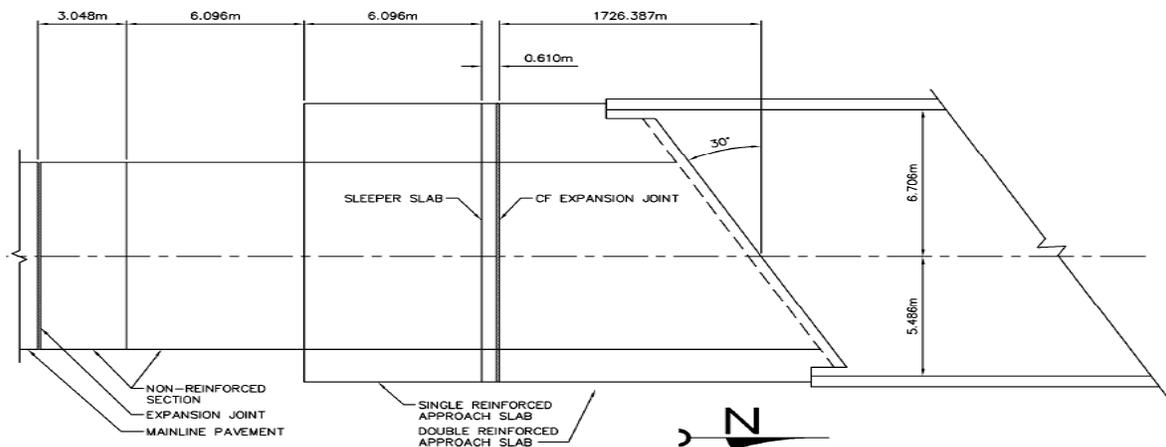
Figure 2.11 Plan view of southbound bridge cast-in-place approach slab (Greimann et al. 2008).

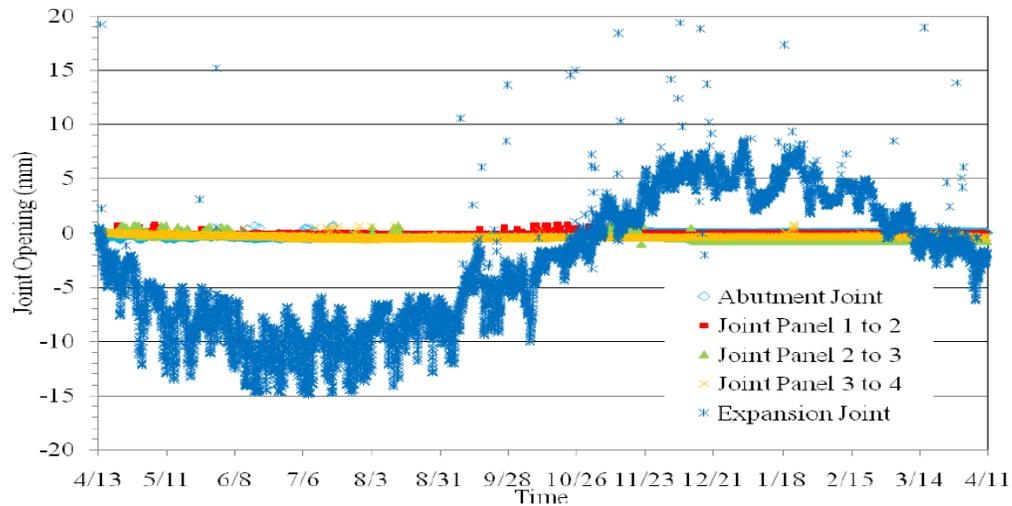
Figure 2.14 Northbound bridge approach slab joint movements (Farris 2009).

The precast approach slab was instrumented with displacement transducers installed across 5 joints (abutment to slab, Panel 1 to 2, Panel 2 to 3, Panel 3 to 4, and expansion joint between Panel 4 and pavement) along with strain transducers in the slab. It was observed that the longitudinal abutment displacement for the northbound bridge was lower than that of the southbound bridge (Farris 2009). This phenomenon was attributed to the difference in the length of approach slabs and the resulting difference in resistance to movement and rotation. However, the transverse abutment displacement for the northbound bridge was found to be higher (almost double) than that of the southbound bridge, and they were observed to have different trends over the year. The reason for this phenomenon was not resolved definitively. The displacement transducers also show negligible relative movement between the panels and between abutment and panels, while the maximum relative movement at the expansion joint was about 1 in. as shown in Figure 2.14 (Farris 2009). The expansion joint movement range for the cast-in-place slab was found to be slightly higher than that of the precast slab, but both slabs follow similar trends in joint opening with time (Greimann et al. 2008).

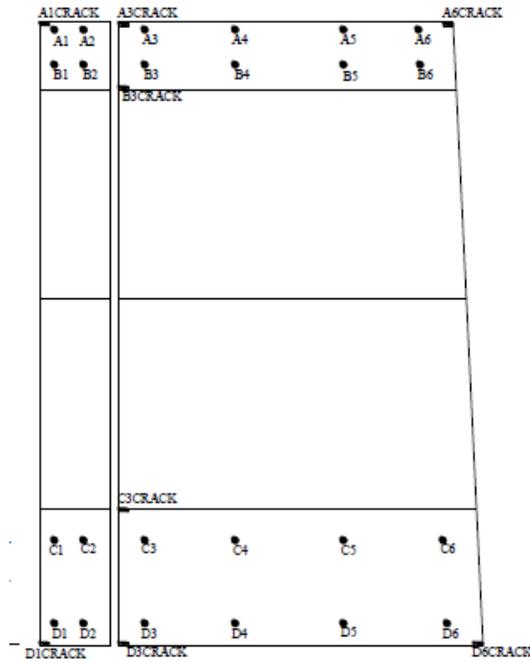
Figure 2.15 Instrumentation plan used for bridge on U.S. 63 near Denver, Iowa (Nadderman and Greimann 2010).

In another study (Nadderman and Greimann 2010), researchers at Iowa State University instrumented approach slabs on a bridge on U.S. 63, west of Denver, Iowa. The three-span concrete girder bridge was 161 ft × 40 ft (49 m × 12.2 m), with a skew of 2°29'52". The approach slab used both precast and cast-in-place shoulder sections. The study aimed to evaluate the performance of approach slabs along with a determination of forces that should be considered during the design of IAB approach slabs. Each approach slab consists of eight 12 in. (304.8 mm) thick precast prestressed panels, except at the abutment where the thickness was reduced to 9.5 in. The four panels at the bridge end of the approach slab are trapezoidal, while the ones at the pavement end are rectangular and dowelled to the pavement. The approach slab was monitored using 32 sensors (24 strain gages and 8 displacement transducers) to record the variation of strain in the approach slab along with the relative movement of approach slab joints. The approach slab dimensions and instrumentation scheme are shown in Figure 2.15.

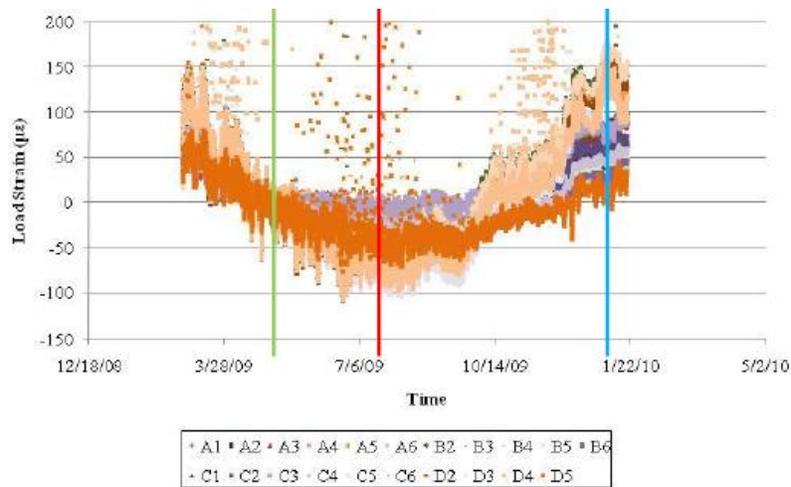
Figure 2.16 Load strain with respect to time for instrumented bridge (Nadderman and Greimann 2010).

The research team defined load strain as the strain caused in the concrete by an applied load or restraints to expansion and calculated it by subtracting the strains caused by thermal expansion/contraction of the slab from the total strain observed at the sensors. They observed that as the temperature decreases, the load strain observed in the slab increases, such that the load strain moves towards compression in the summer season and tension in winter. The load strains vs. time observed for all the working gauges are shown in Figure 2.16.

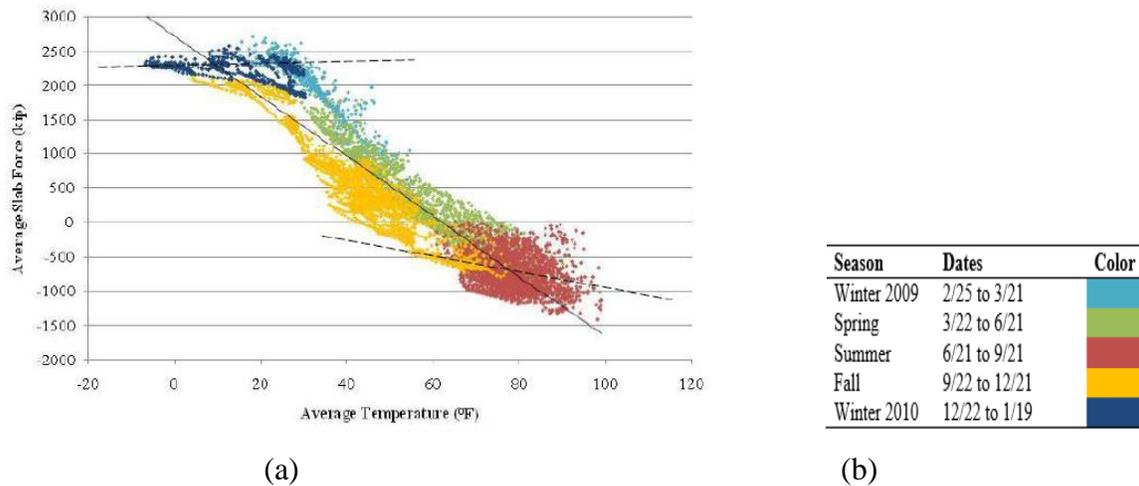
Figure 2.17 (a) Average slab force with respect to average temperature; (b) Legend (Nadderman and Greimann 2010).

The average load strain was calculated by averaging the load strains at each of the working sensors, which was in turn used to calculate the average slab force. This was plotted against the average temperature of the slab, and it was observed that the average slab force follows a cyclic pattern. The change in force in the slab ranged from -1166 kips in the summer to 2996 kips in the winter (where tension is negative), showing significant forces applied due to live load and constraints from the boundary conditions, as shown in Figure 2.17.

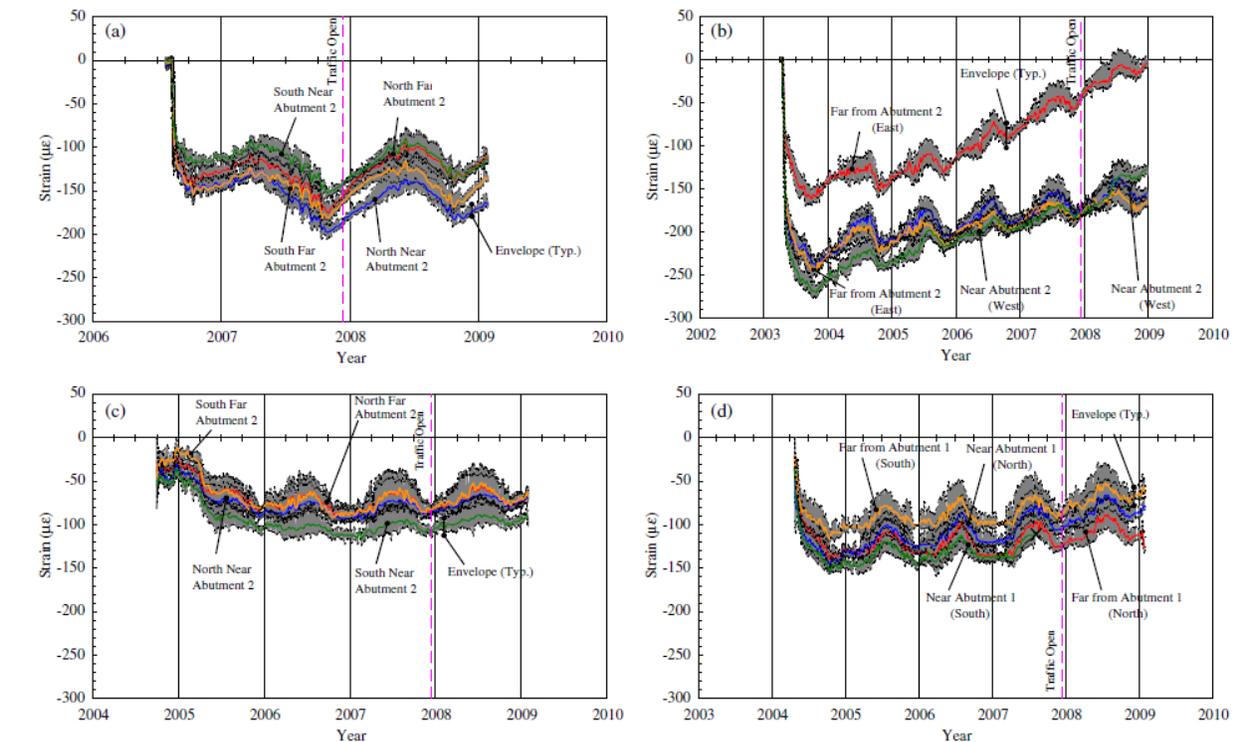
Figure 2.18 Approach slab strains near abutment 2: (a) bridge 109; (b) bridge 203; (c) bridge 211; (d) bridge 222 (Kim and Laman 2014).

the compressive strains decreased, as seen especially prominently for Bridge 203, which was designed and constructed following AASHTO specifications and had only one end of the bridge with an integral abutment. This phenomenon was much less pronounced in other bridges, with both sides having integral abutments. Approach slab strains for the 4 bridges are shown in Figure 2.18.

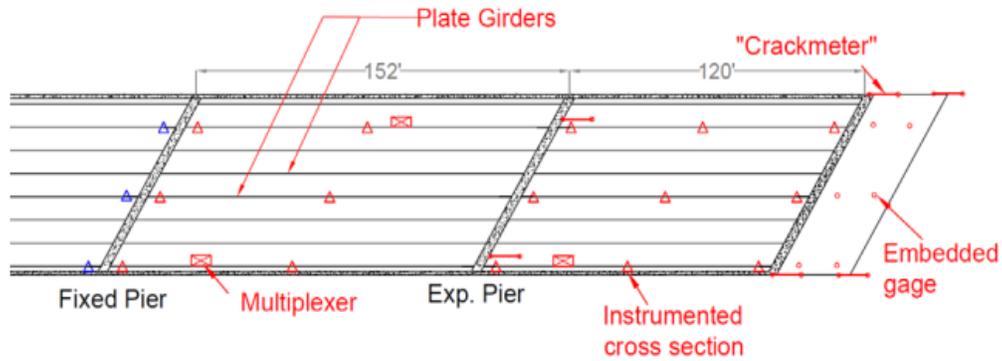
Figure 2.19 Instrumentation plan for Kishwaukee River Bridge (LaFave et al. 2017).

The structural response of IAB superstructures and substructures was studied at the University of Illinois (LaFave et al. 2016, 2017). The field monitoring program included collecting data about: (a) global bridge movements; (b) pile, deck, girder, and approach-slab strains; and (c) rotations at different abutment interfaces. The superstructure and substructure of the Union Pacific Railroad (UPRR) and Kishwaukee River bridges (I-90 mainline bridges) were instrumented with strain gages on girders and piles, tiltmeters, and displacement transducers. The instrumentation plan used for the longer bridge in the study is given in Figure 2.19.

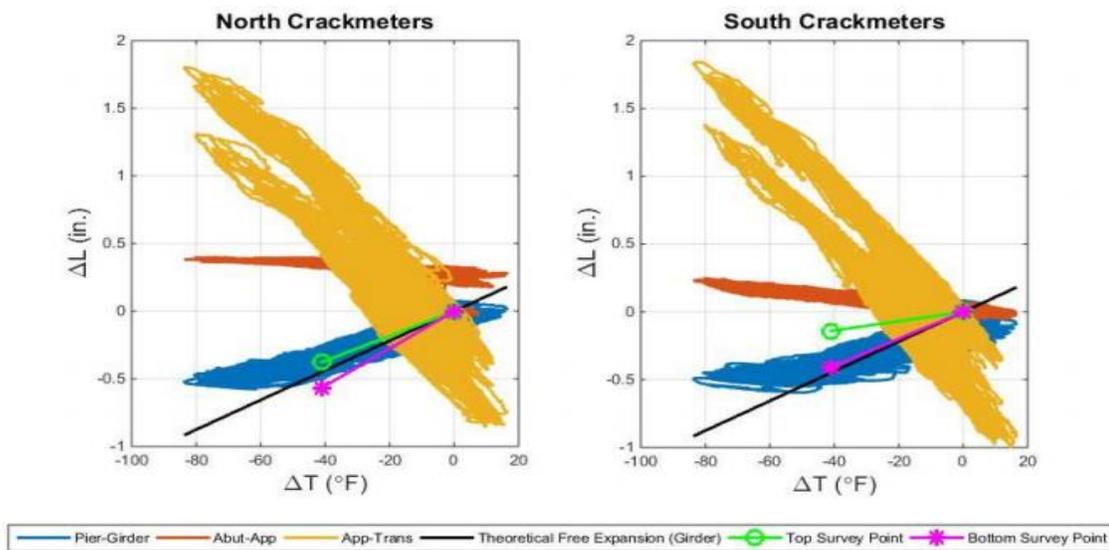
Figure 2.20 Kishwaukee River Bridge displacement transducer data (LaFave et al. 2017).

Displacement transducer data showed that the change in length of the joints followed a linear trend with respect to the temperature of the slab, as seen in Figure 2.20. The approach slab-transition slab interface showed the largest displacement magnitudes, as expected, as it is the location of the expansion joint where relative displacements are intended to occur. The data can be observed to follow distinct lines with almost the same slope but a significant shift, which happened after a full year of data collection. This was attributed to the bridge overcoming some resistance and thus closing the joint to a new permanent displacement. The other end of the slab (at the abutment) showed a much lower magnitude of relative displacement, which was expected due to reinforcing steel continuity across this construction joint.

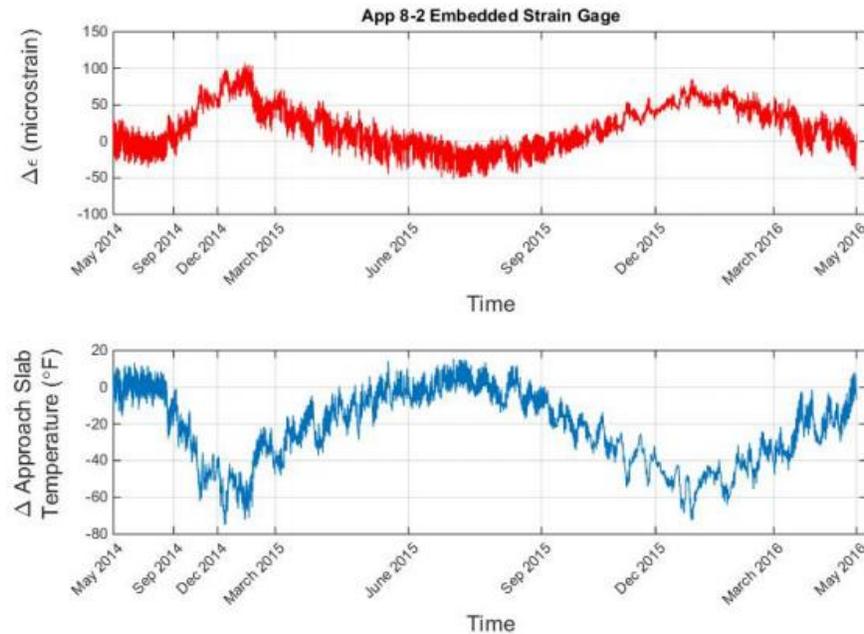
Figure 2.21 Variation of approach slab gauge strain and temperature with time for the Kishwaukee River Bridge (LaFave et al. 2017).

The strain developed in the approach slab was observed to be highly correlated to the temperature variation, which follows the findings of previous studies covered in this chapter. The variation of strain with change in temperature is shown in Figure 2.21.

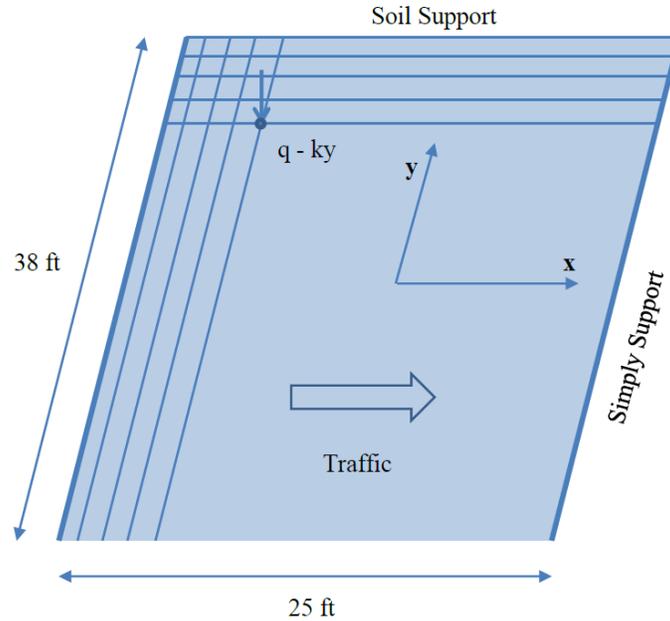
Figure 2.28 Plan view of the approach slab model (Ma 2011).

The study conducted by the researchers at the University of Missouri-Columbia focused on the development of equations for the uniaxial and biaxial bending behavior of a slab on elastic soil support. The wash-out of soil, which is similar to void development, was considered in the research. The approach slab was modeled as a 38 ft × 25 ft (11.58 m × 7.62 m) plate and discretized into 0.5 ft × 0.5 ft (0.15 m × 0.15 m) elements. Figure 2.28 shows the approach slab model. For a simply-supported edge, bending moment perpendicular to the edge and displacement is zero; for a soil supported edge, bending moment and shear are zero; for corner nodes, the twisting moment is zero.

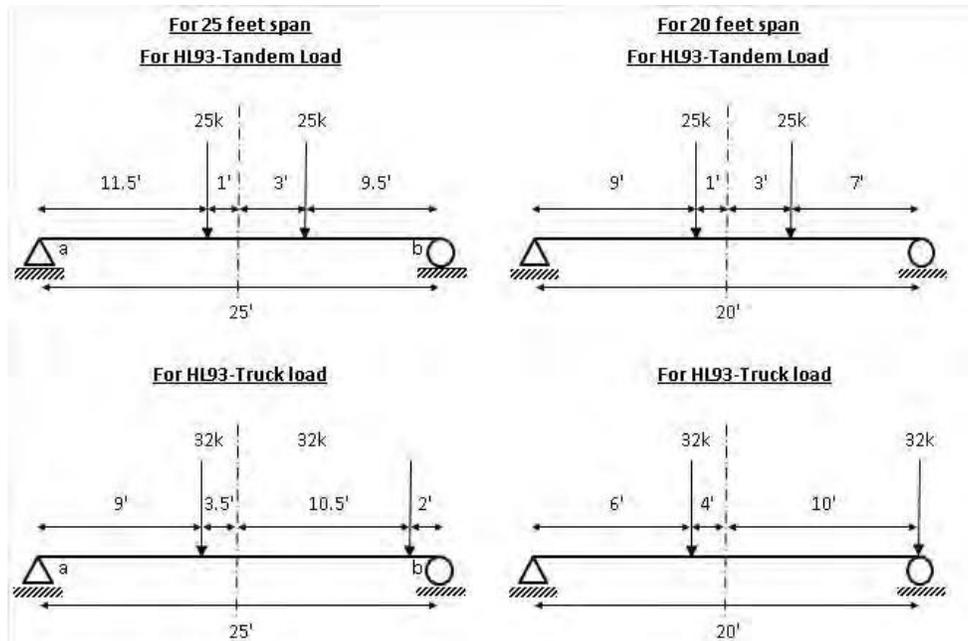
Figure 2.30 Load locations for maximum bending moment in simply supported slabs (Thiagarajan et al. 2010).

A very poor soil condition with subgrade modulus of 18.4 lb/in/in^2 (2.89 kN/m/m^2) was selected. The loading of the model was based on AASHTO LRFD specifications. The design truck with three axles and a gross weight of 72 kips (320.27 kN) was considered along with the design lane load. The tandem load was also considered along with the lane load. The design truck was 6 ft wide, and the distance between the front axle and middle axle was 14 ft (4.27 m). The distance between the middle axle and the rear axle was considered as 14 ft (4.27 m) as the span of the approach slab modeled was either 20 ft (6.1) or 25 ft (7.62 m). The loading has been applied in steps, with three design trucks entering the slab at the slab-pavement end and then traversing the slab. Figure 2.30 shows the location of critical loads with simply supported boundary conditions.

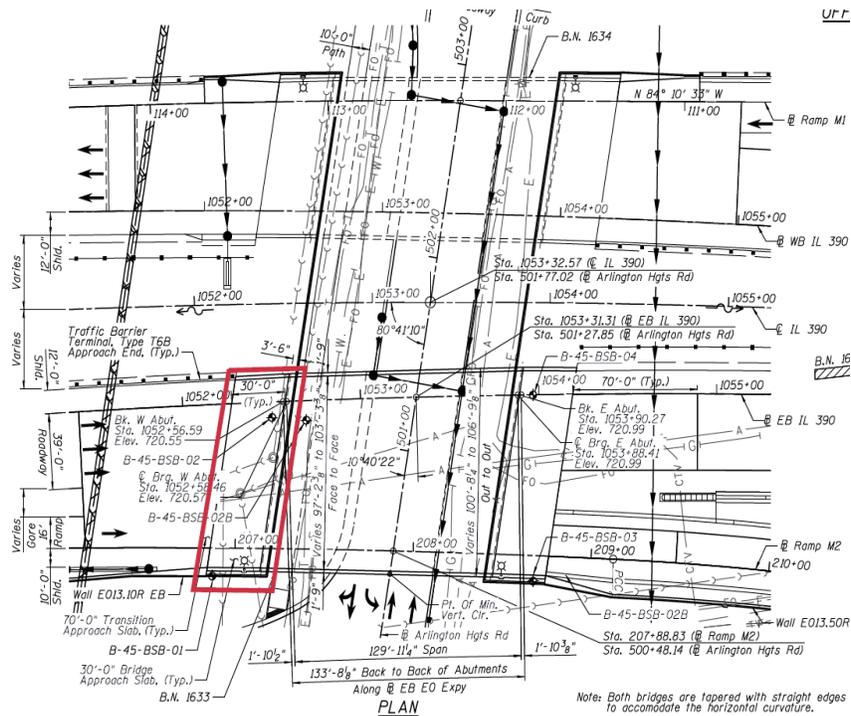
Figure 3.1 Instrumented EB-W approach slab at Arlington Heights Road (cast-in-place).

The EB-W approach slab of the Illinois Route 390 Bridge over Arlington Heights Road (cast-in-place) was selected for instrumentation; the location of the slab is highlighted in Figure 3.1. This approach slab consists of seven sections: North Shoulder (NS), Lane 1 (L1), Lane 2 (L2), Lane 3 (L3), Gore (G), Ramp (R), and South Shoulder (SS). Concrete for all sections of the slab was poured integrally.

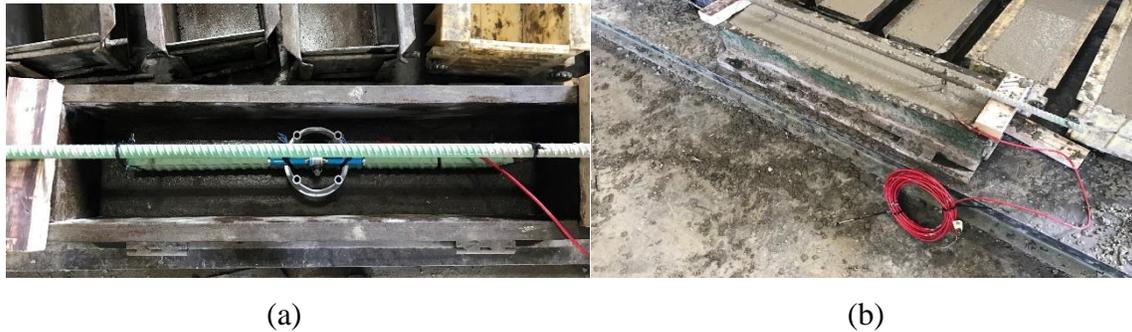
Two temperature compensation beams were fabricated as the bridges were constructed, as shown in Figure 3.8. The 6 in. × 6 in. × 30 in. beams have a longitudinal bottom #8 bar, similar to the reinforcement used in the slabs. The temperature beams were cast with an embedded strain sensor mounted on the reinforcement to record the strain and temperature of the beam. These beams were used to estimate the coefficient of thermal expansion of both slabs.

Figure 3.8 (a) Temperature beam with embedded gage and reinforcement bars; (b) the temperature compensation beams being cast.

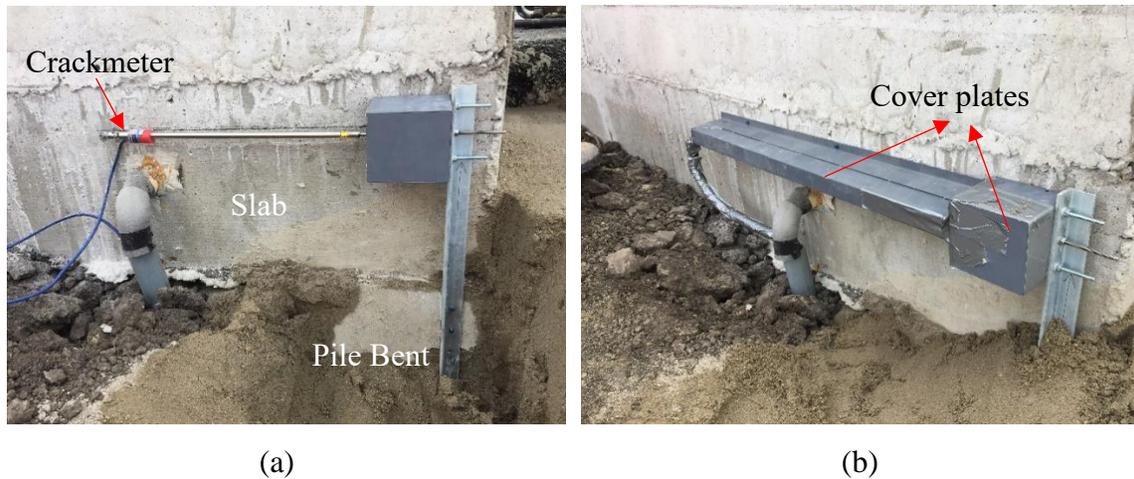
Figure 3.10 (a) Installation of NW displacement transducer (Arlington Heights Road); (b) Cover plates of NW displacement transducer (Arlington Heights Road).

- At the North side of the approach slab for the Arlington Heights Road bridge, a regular Tollway asphalt shoulder was constructed on the other side of the expansion joint. Therefore, the displacement transducer (6 in. range) at the northwest end was anchored to the slab, and the pile bent.
- At the southwest corner of the slab for Arlington Heights Road Bridge, the approach slab was not accessible for instrumentation. Therefore, the displacement transducer was anchored at the barrier of the approach slab and moment slab.

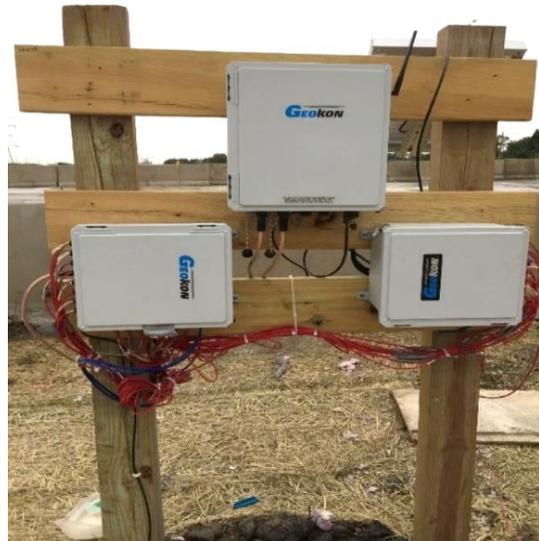
Figure 3.11 (a) The multiplexer, datalogger, solar panel and temperature beam at Arlington Heights Road (cast-in-place); (b) The multiplexer and datalogger at Prospect Avenue (precast).

A datalogger, two multiplexers, and a solar panel were installed on posts at each bridge, using the same installation plan for both slabs. Two multiplexers were mounted below the datalogger, which was under the solar panel. The terminal boxes were mounted on three pieces of 4 in. by 6 in. pressure-treated lumber, as shown in Figure 3.11. The solar panel was installed at the top of one post, with the tilt of the panel set to be approximately equal to the latitude at the location (about 41.9°) in order to yield the maximum solar energy throughout the year. The temperature compensation beam was placed on top of gravel between the posts at each bridge. All wires were connected to two multiplexers based on the selection of certain sensors to also provide temperature readings. The modem for remote communication was installed in the datalogger box, as shown in Figures 3.12.

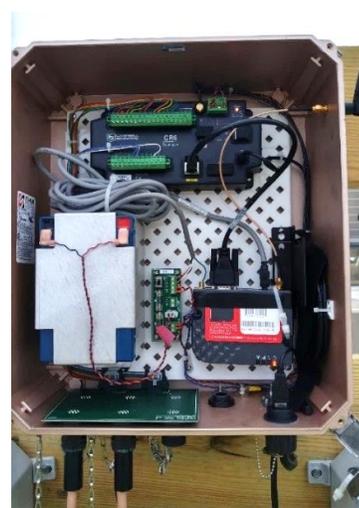
Figure 3.12 (a) Inside of datalogger after modem was installed at Arlington Heights Road (cast-in-place); (b) Inside of datalogger after the modem was installed at Prospect Avenue (precast).

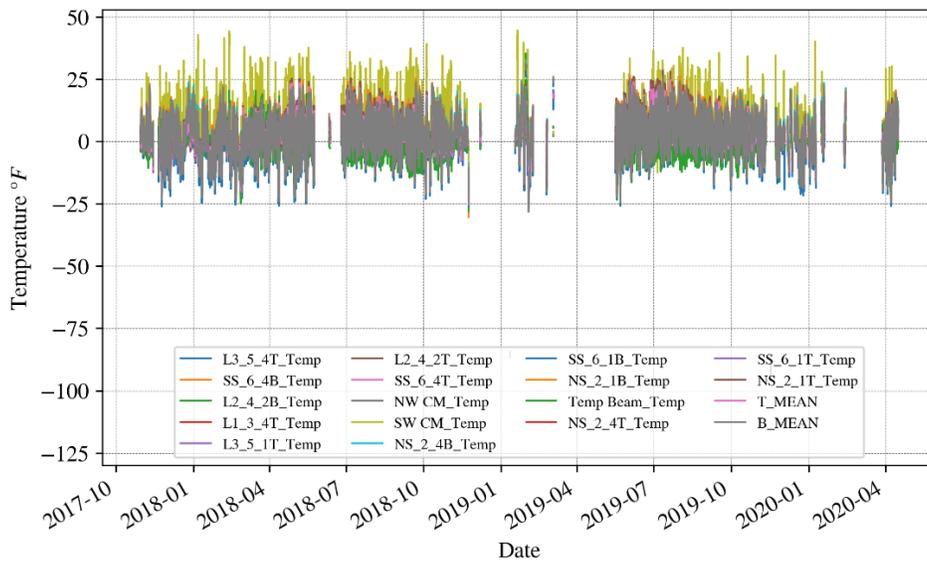
Figure 4.3 Difference between sensor temperatures and O’Hare station dry-bulb temperature (Prospect Avenue).

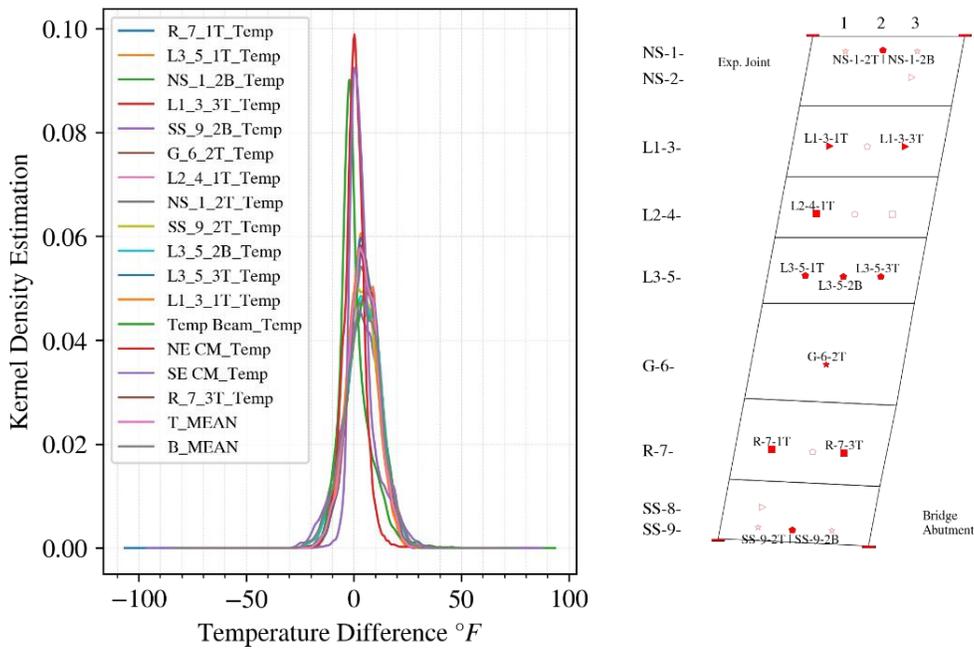
Figure 4.4 Distribution of difference between sensor temperatures and O'Hare dry-bulb temperature (Arlington Heights Road).

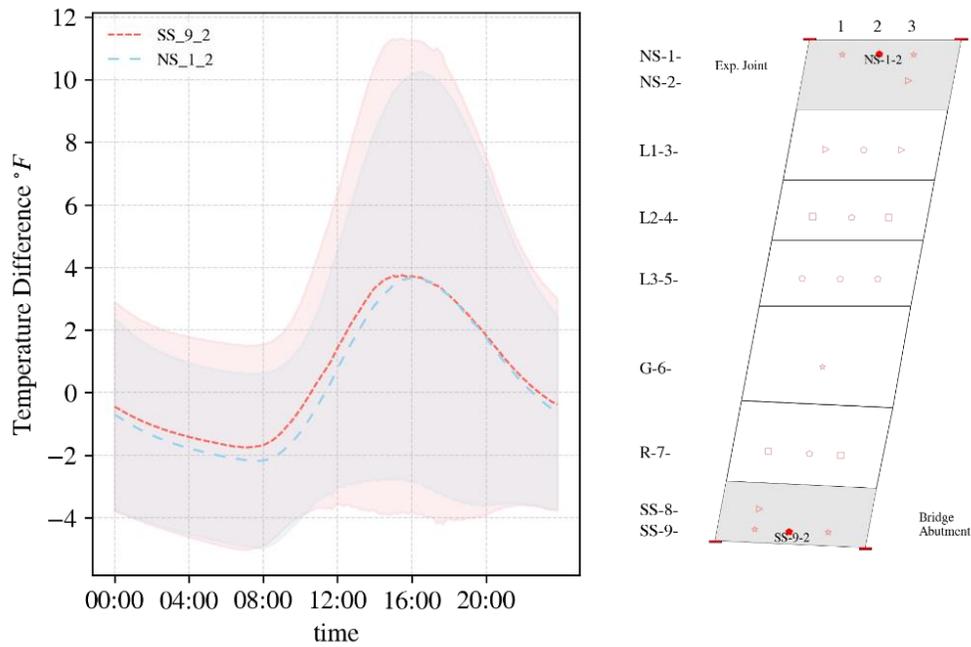
Figure 4.8 Top-bottom temperature difference trend (Arlington Heights Road).

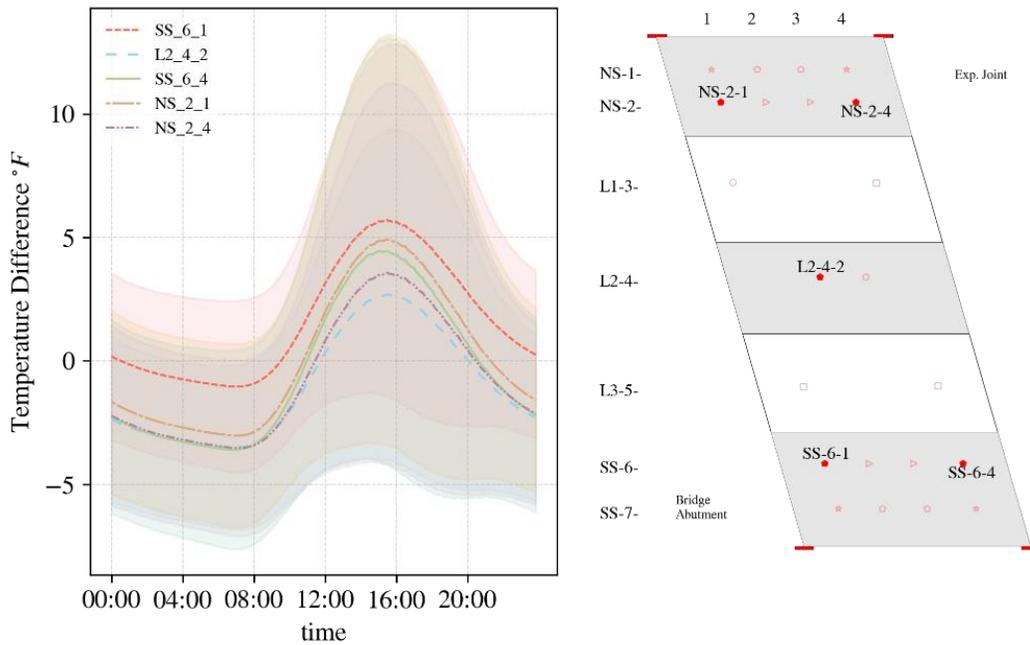
Figure 4.9 Top-bottom temperature difference trend (Prospect Avenue).

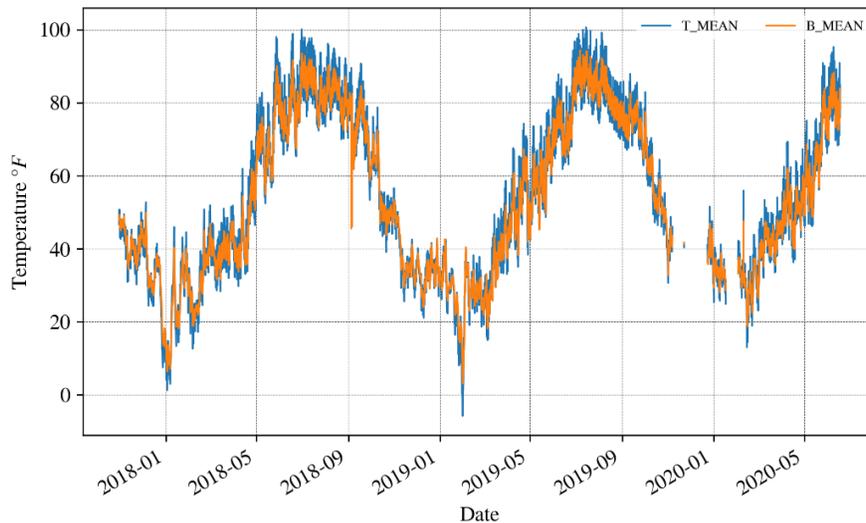
Figure 4.10 Top and bottom average temperature time history (Arlington Heights Road).

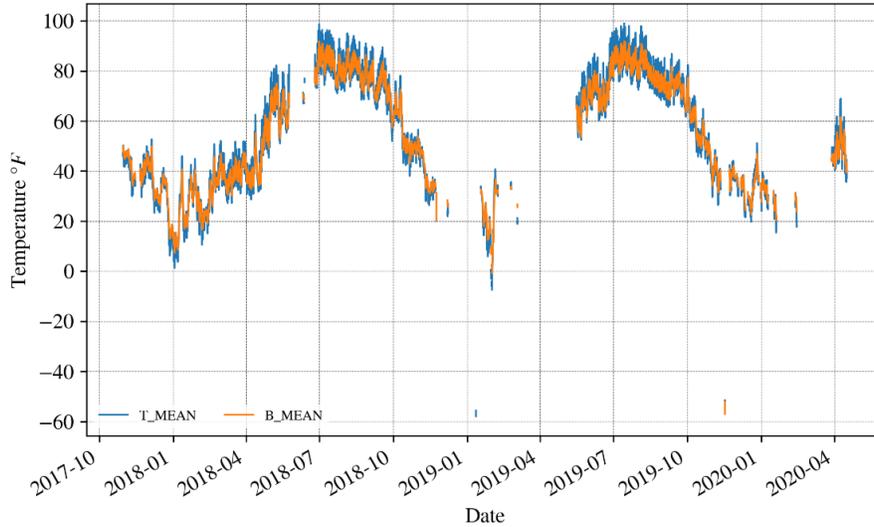
Figure 4.11 Top and bottom average temperature time history (Prospect Avenue).

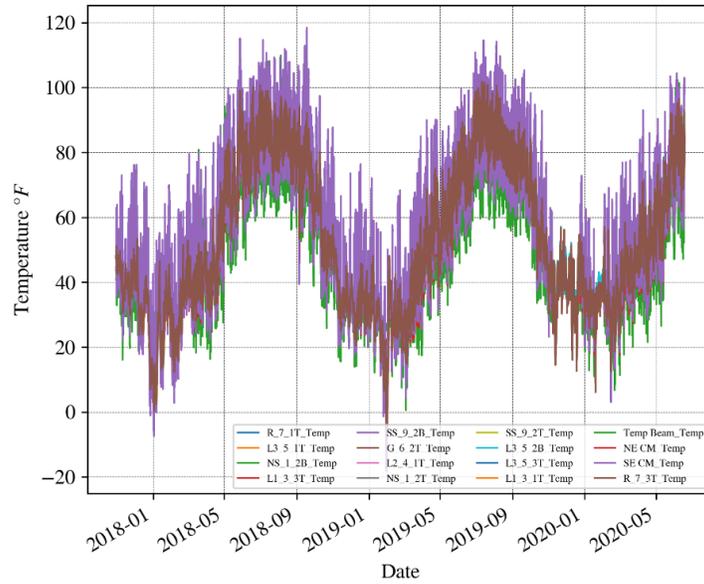
Figure 4.12 Time history of temperatures with estimated temperature data filling gaps (Arlington Heights Road).

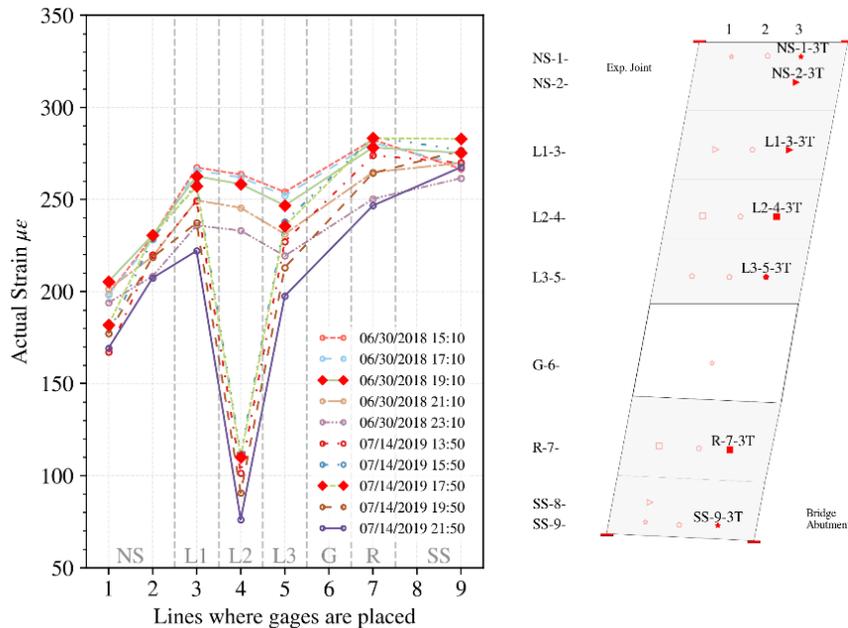
Figure 4.24 Top actual strain changes along the bridge abutment end during the hottest time (Arlington Heights Road).

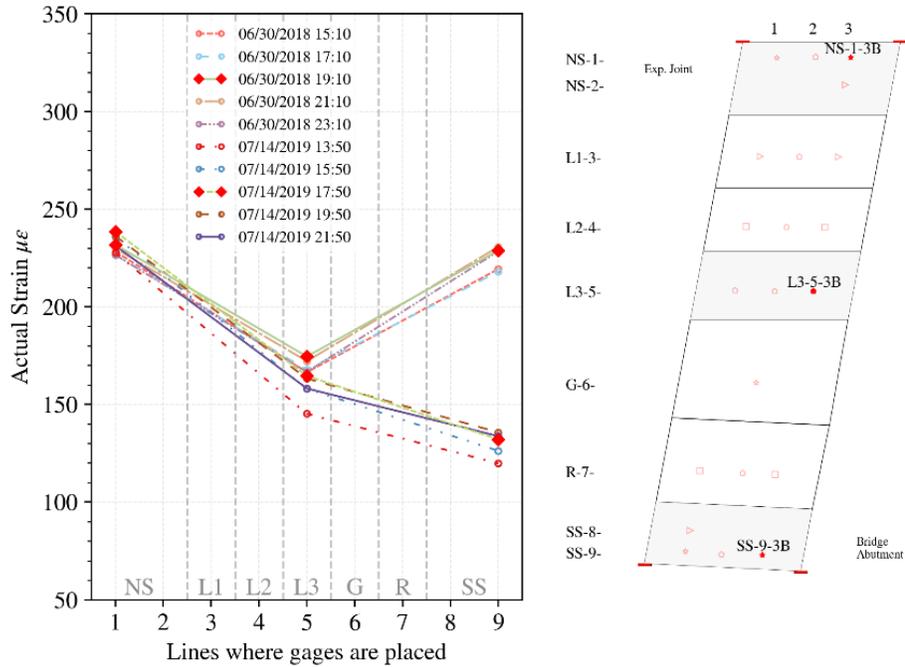
Figure 4.25 Bottom actual strain changes along the bridge abutment end during the hottest time (Arlington Heights Road).

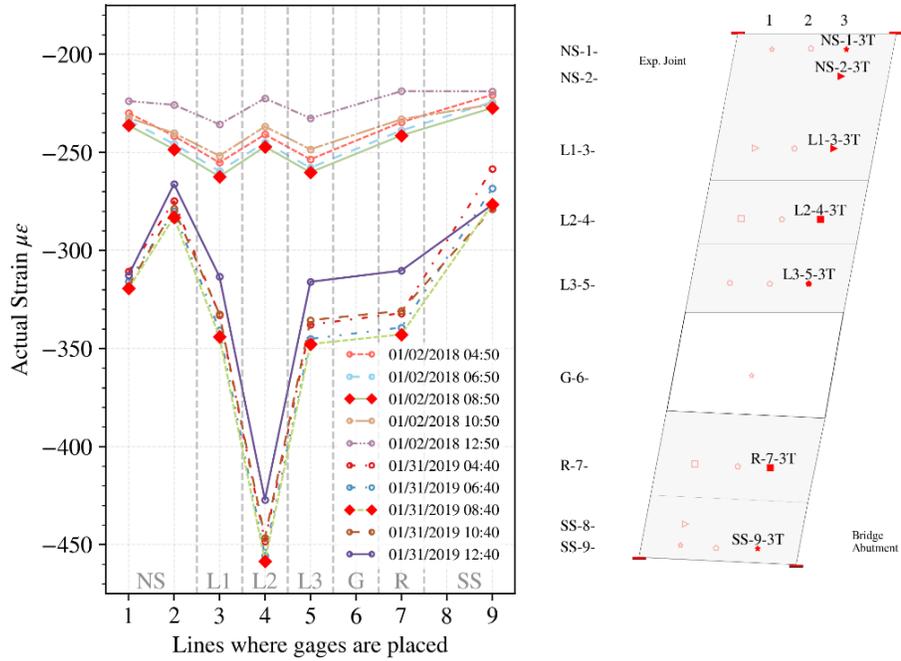
Figure 4.26 Top actual strain changes along the bridge abutment end during the coldest time (Arlington Heights Road).

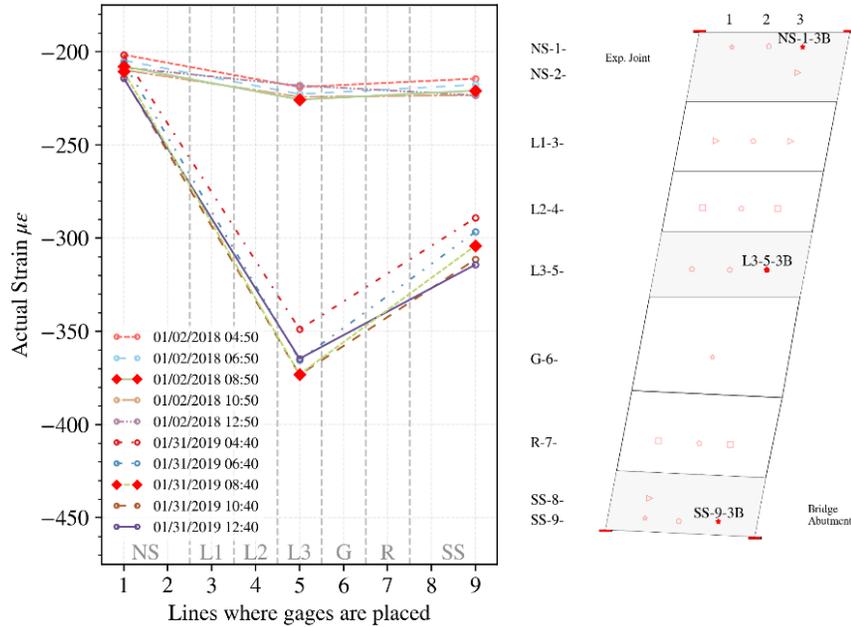
Figure 4.27 Bottom actual strain changes along the bridge abutment end during the coldest time (Arlington Heights Road).
