**Investigation of Approach Slab Construction and Evaluation of Modular Approach
Slab Designs**

Final Report

**University of Illinois at Urbana-Champaign
Department of Civil and Environmental Engineering
January 2021**

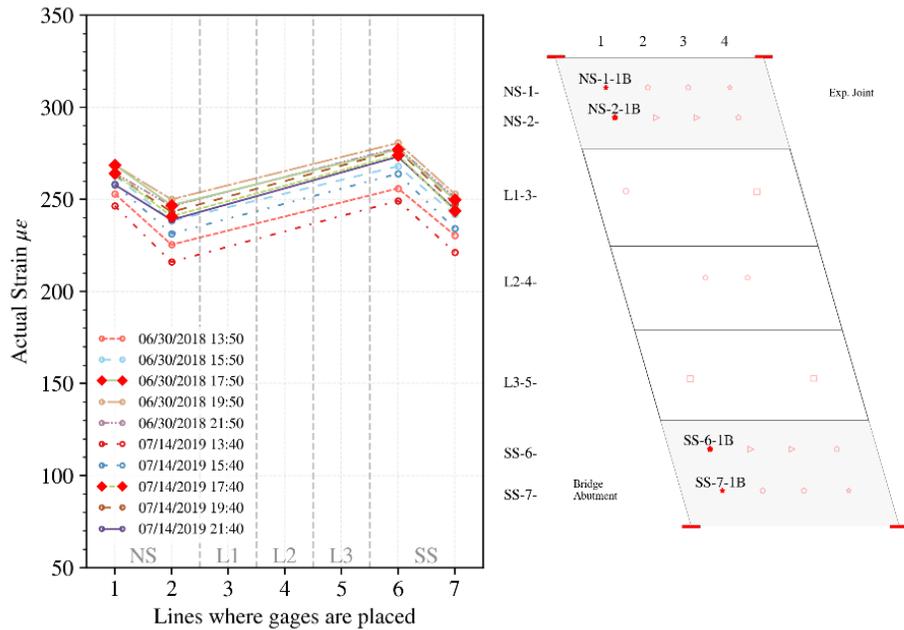
Figure 4.29 Bottom actual strain changes along the bridge abutment end during the hottest time (Prospect Avenue).

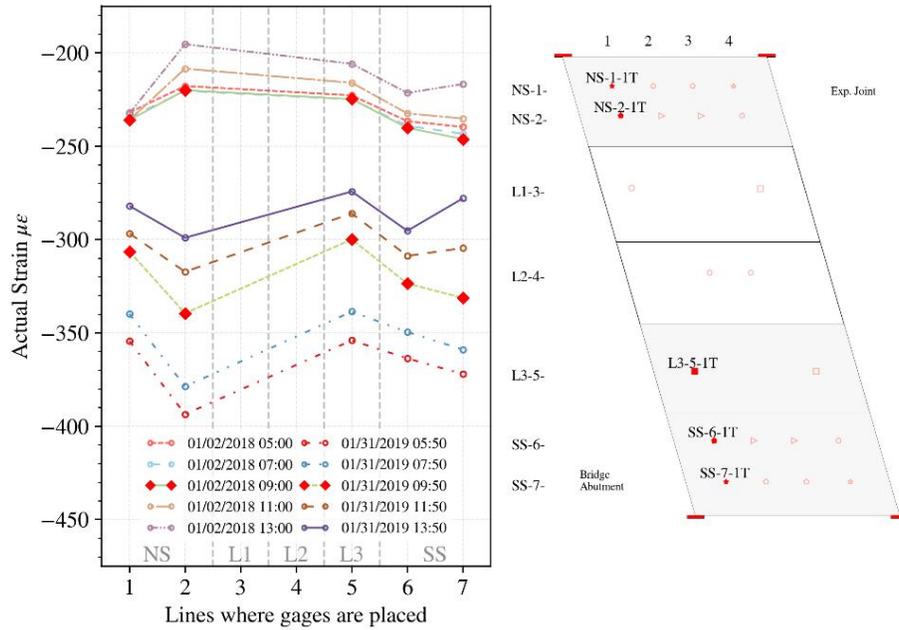
Figure 4.30 Top actual strain changes along the bridge abutment end during the coldest time (Prospect Avenue).

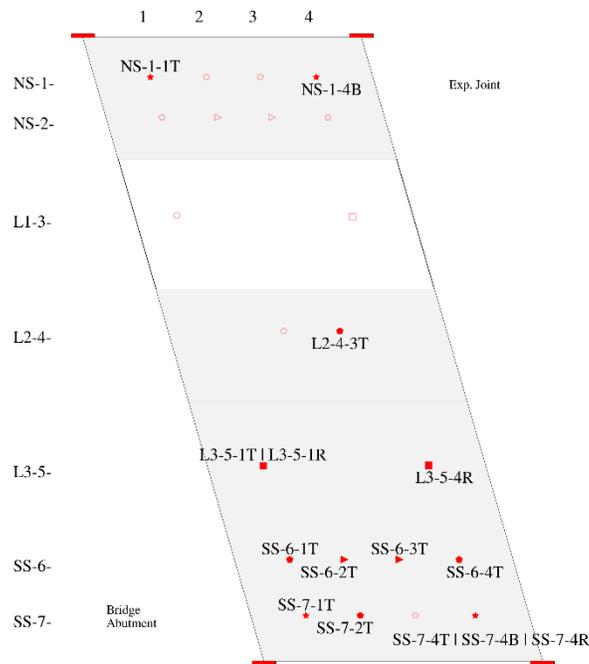
Figure 4.41 Gages with Group 2 strain behavior (Prospect Avenue).

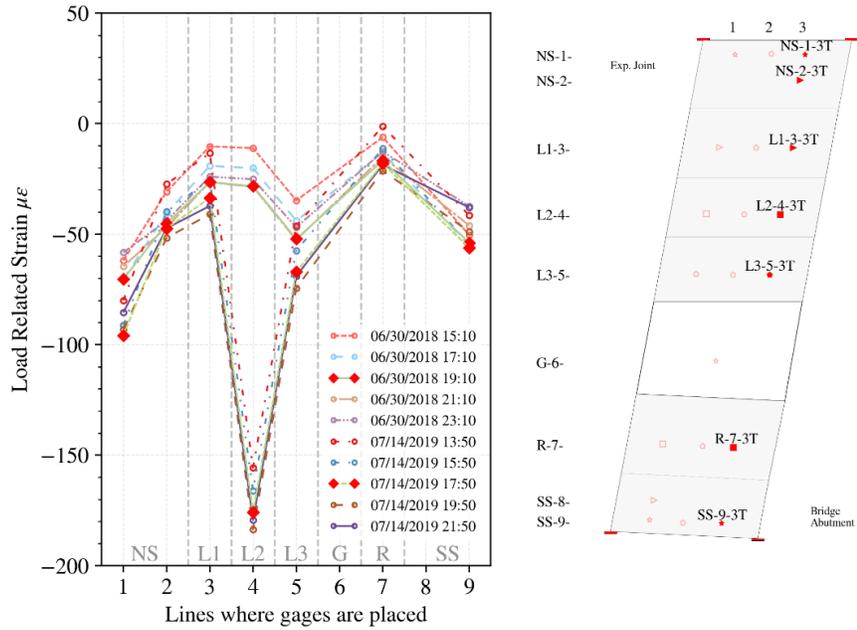
Figure 4.46 Top load-related strain changes along the bridge abutment end during the hottest time (Arlington Heights Road).

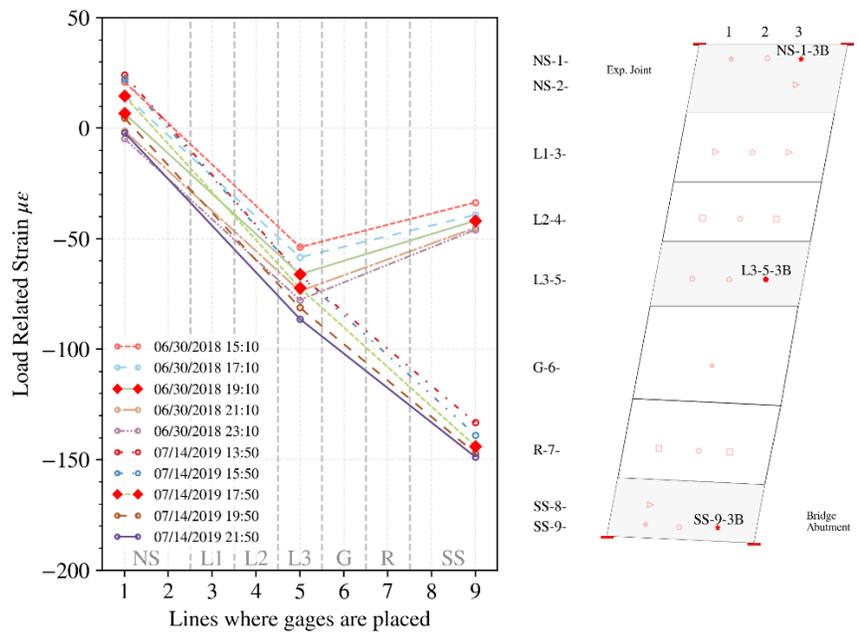
Figure 4.47 Bottom load-related strain changes along the bridge abutment end during the hottest time (Arlington Heights Road).

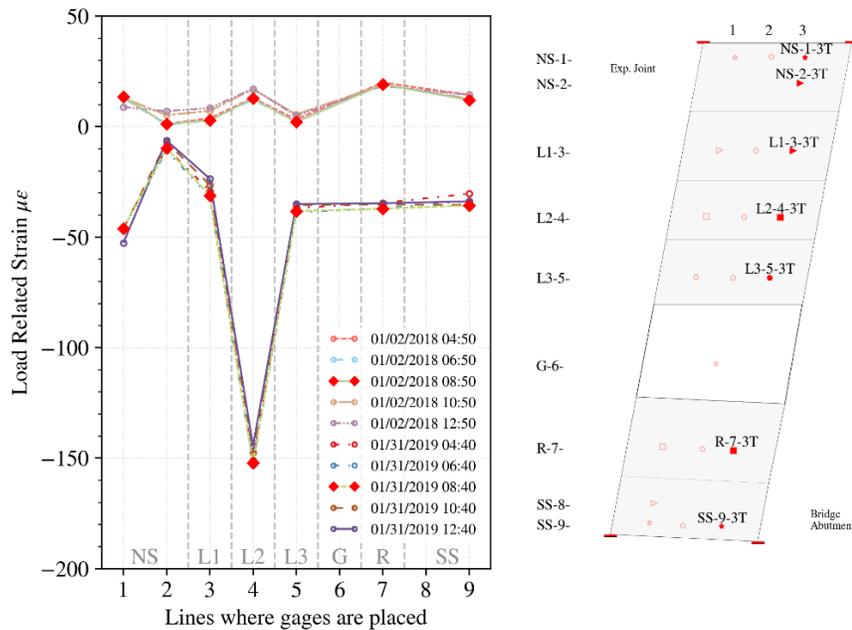
Figure 4.48 Top load-related strain changes along the bridge abutment end during the coldest time (Arlington Heights Road).

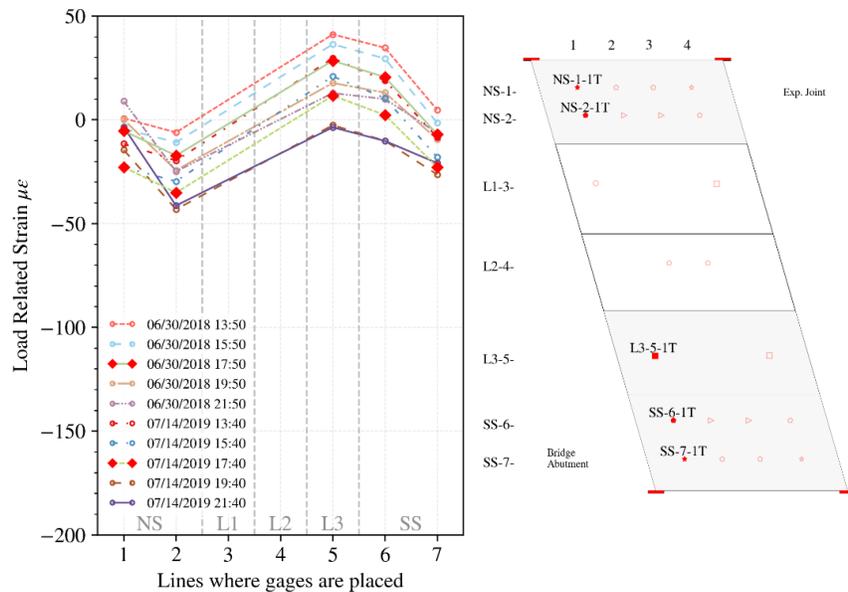
Figure 4.50 Top load-related strain changes along the bridge abutment end during the hottest time (Prospect Avenue).

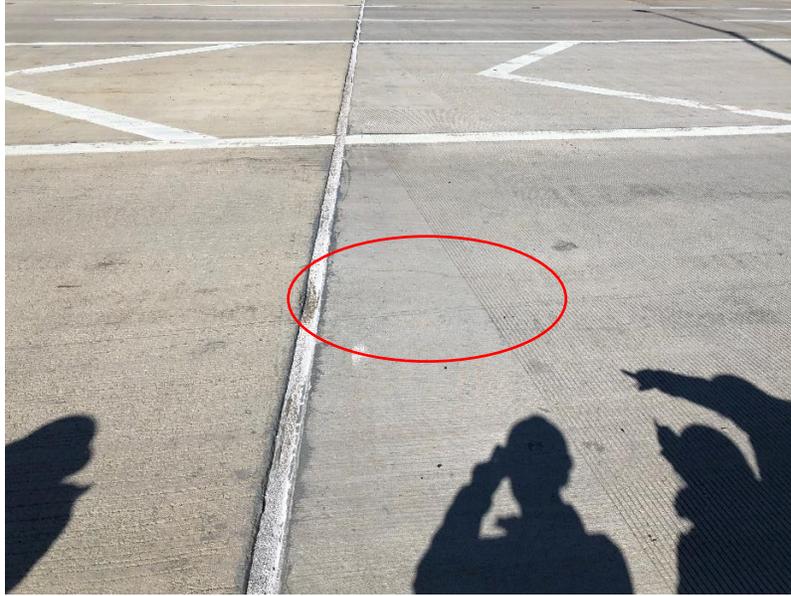
Figure 4.62 Crack found at the entrance of ramp (Arlington Heights Road) on 03/09/2018.

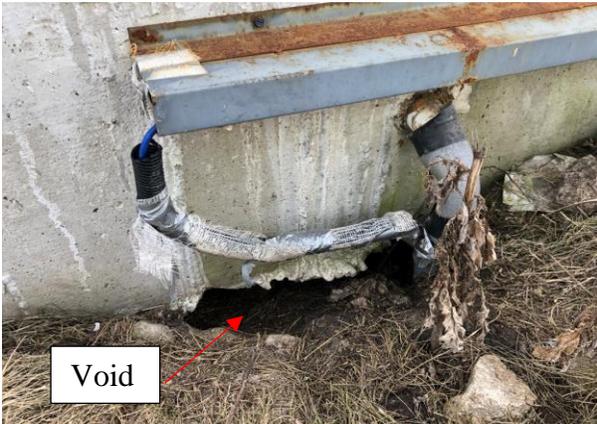
(a)

More recent field visits found that voids developed at least near the north or south boundary of both slabs, as shown in Figure 4.65. The condition of slab bottom surface still remains unknown.

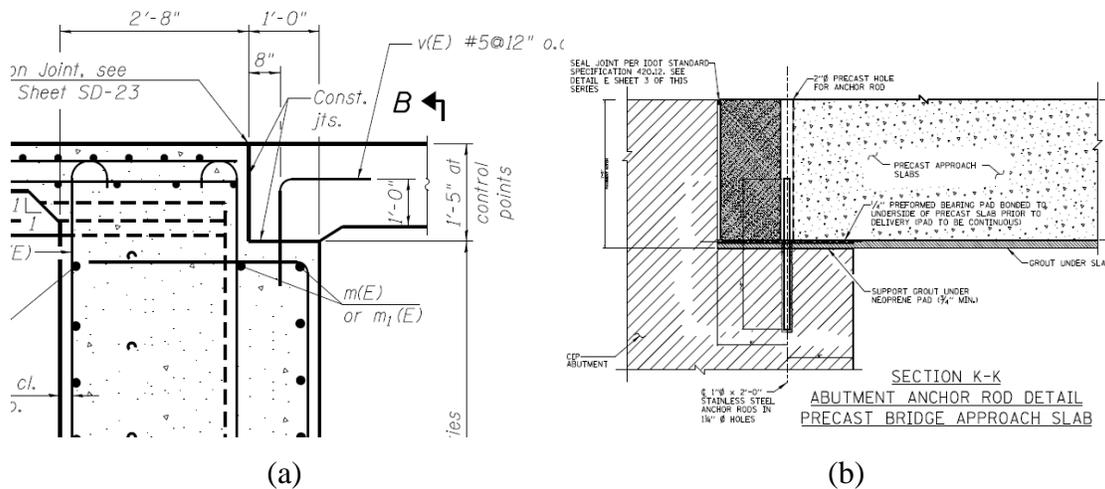
Figure 5.3 Details of dowel bars at the abutment-approach slab interface: (a) cast-in-place, (b) precast.

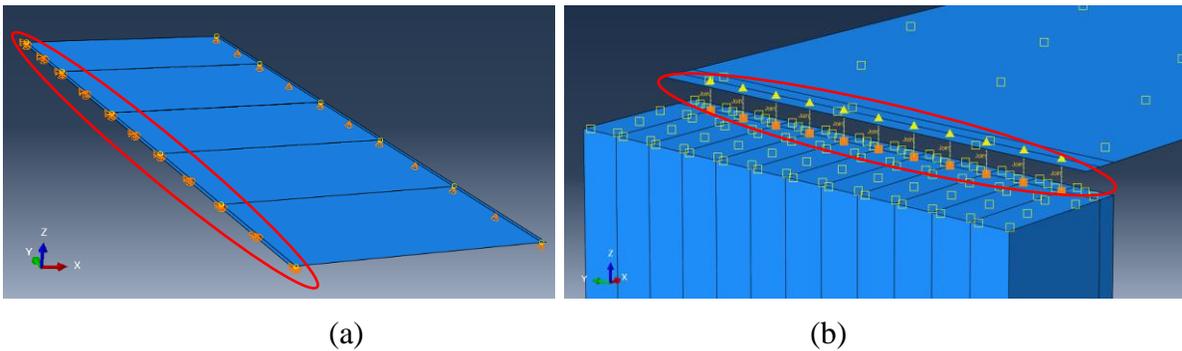
Figure 5.6 Boundary conditions at the abutment-approach slab interface: (a) hinge, (b) connectors.

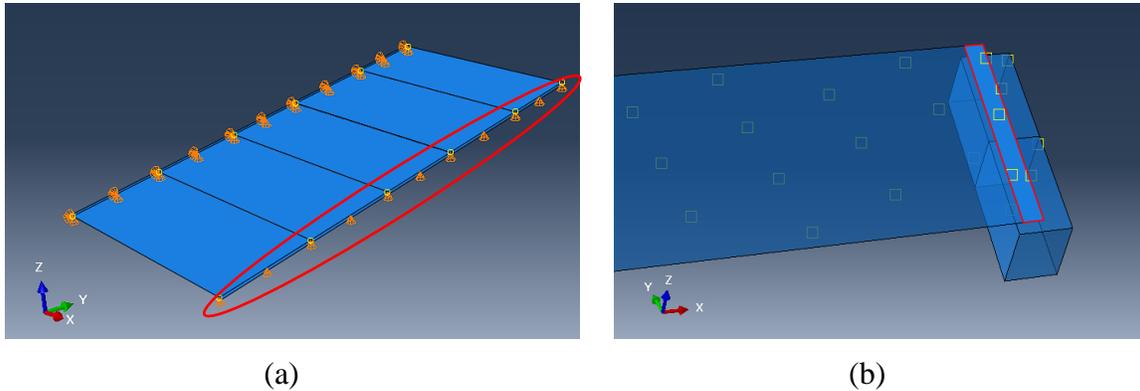
Figure 5.7 Boundary conditions at the approach slab-pile bent interface: (a) roller, (b) surface interaction.

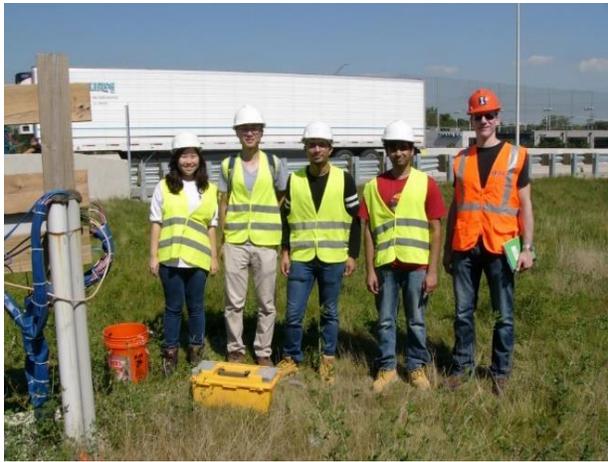
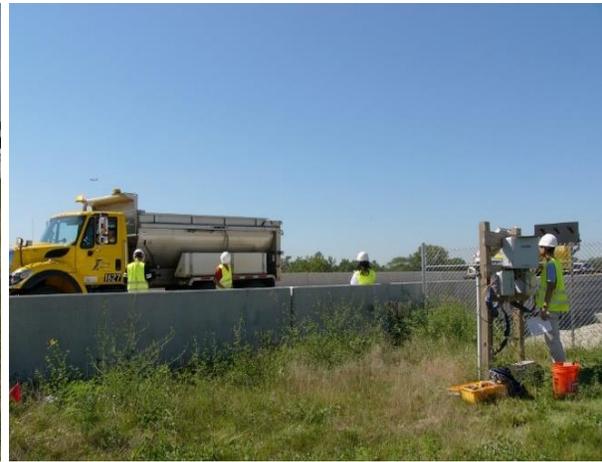
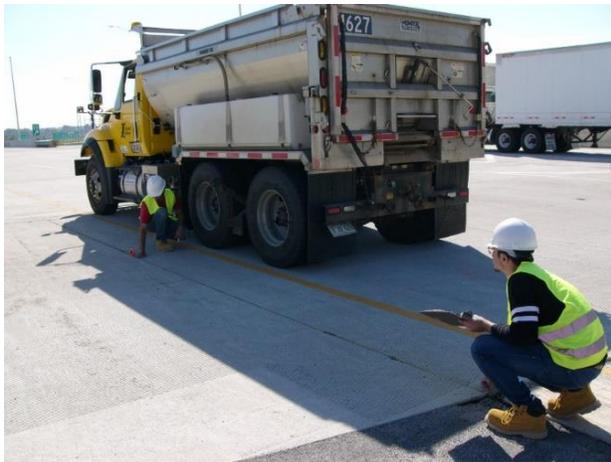
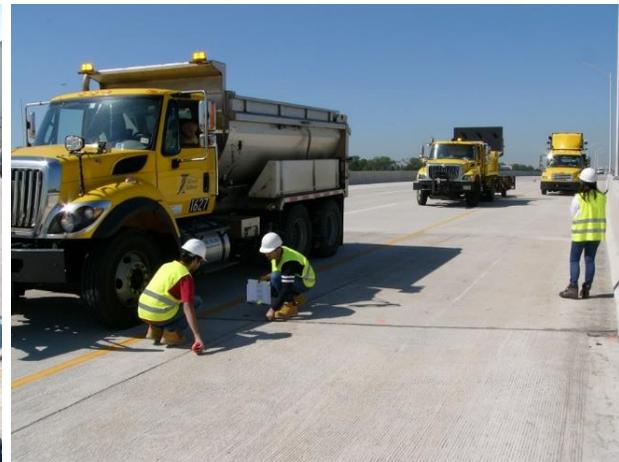
Figure 6.2 Research team conducting static truck loading test: (a) U of I research team (b) testing location with the team working on truck placement and data collection; (c) measurement of rear axle location; (d) measurement of front axle location.

Figure 6.2 (a) to (d) show the process of the static loading truck test carried out by the research team on 9/14/2018.

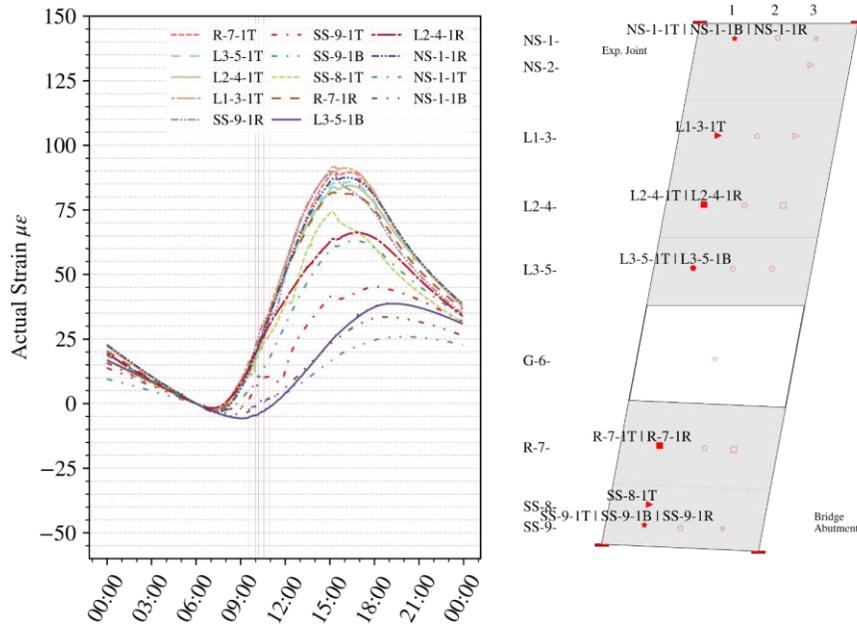
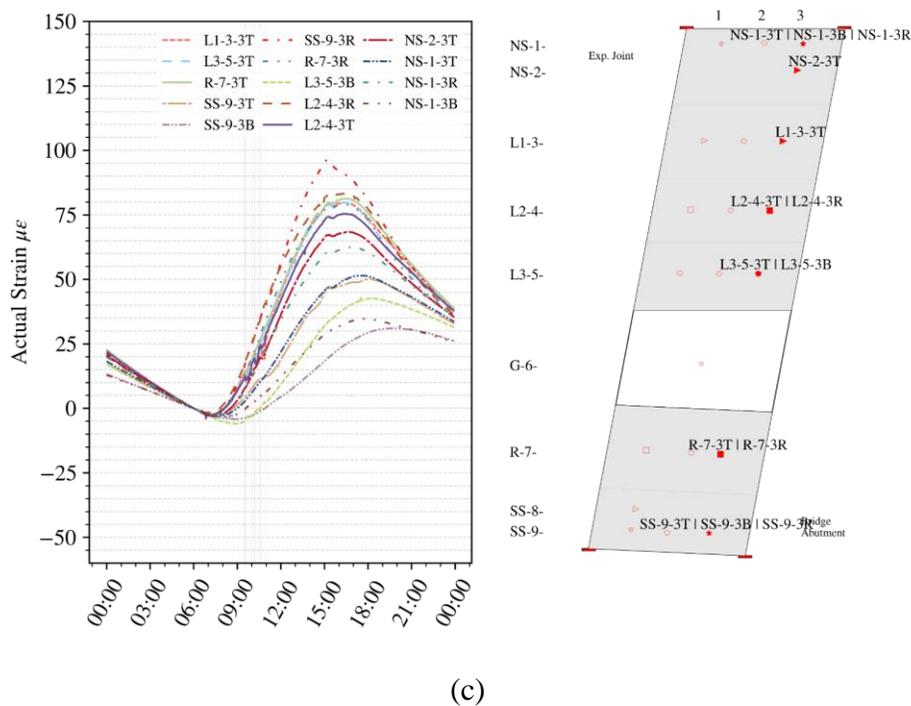
Figure 6.4 Actual Strains at Arlington Heights Road on 9/14/2018 at (a) transverse line 1, (b) transverse line 2, and (c) transverse line 3.

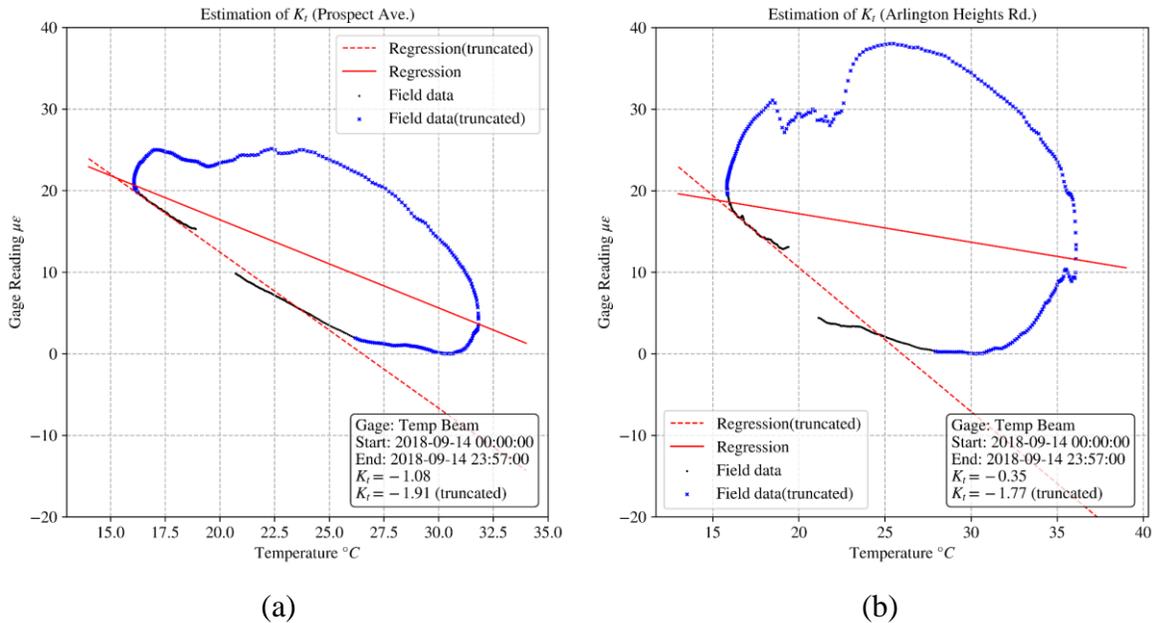
Figure 6.12 Apparent strain vs. temperature for temperature compensation beams: (a) Prospect Avenue, (b) Arlington Heights Road.

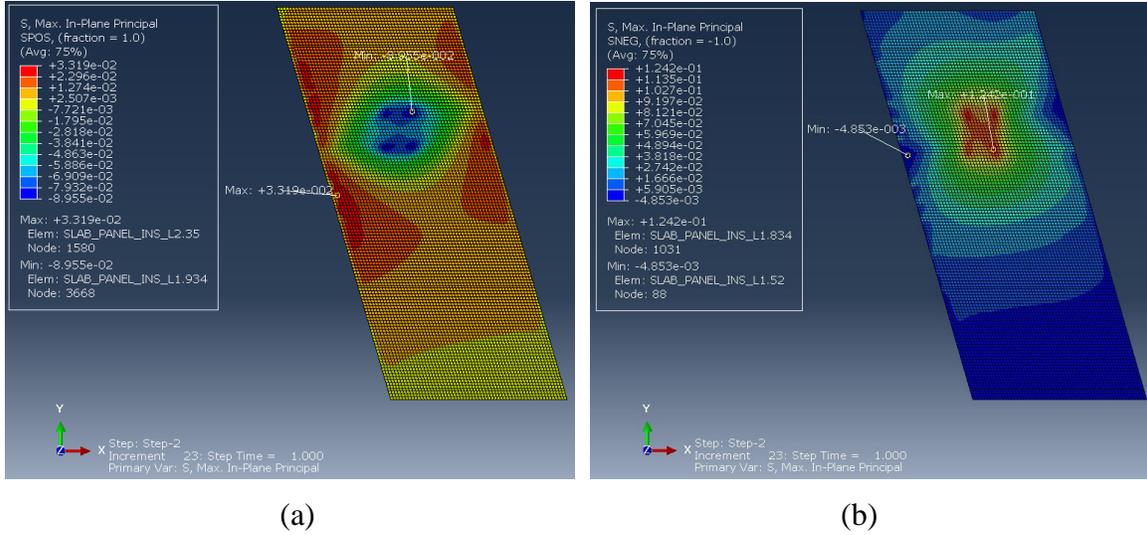
Figure 6.29 Principal stress (ksi) distribution of the precast slab (Prospect Avenue) for truck test 5 at: (a) top surface and (b) bottom surface.

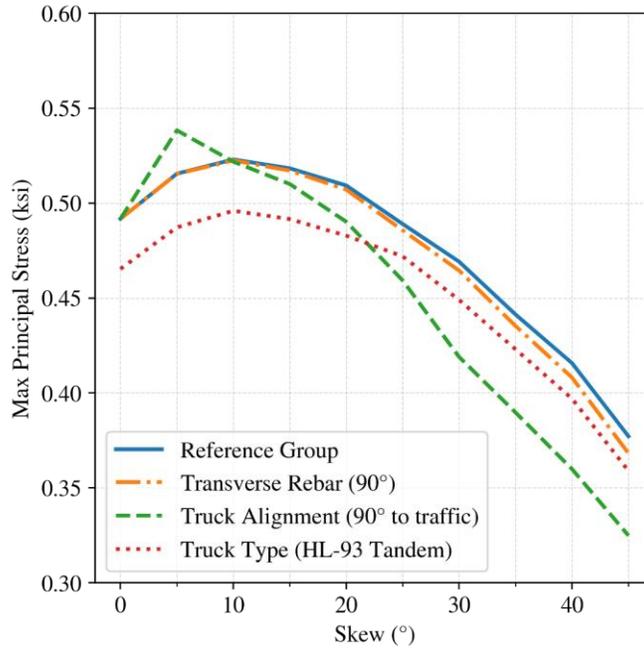
Figure 7.6 Critical principal stresses under live load considering truck type, truck alignment, and transverse rebar direction.

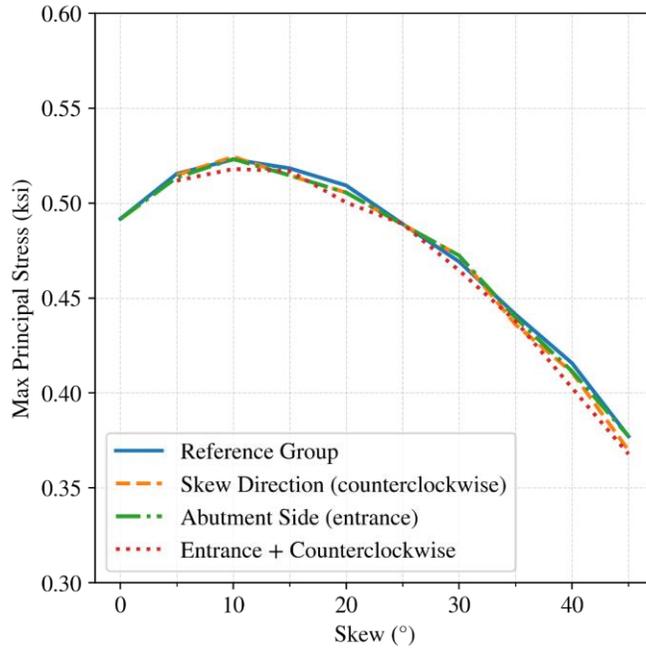
Figure 7.8 Critical principal stresses of the approach slab under IL-120 design truck with respect to geometric variables.

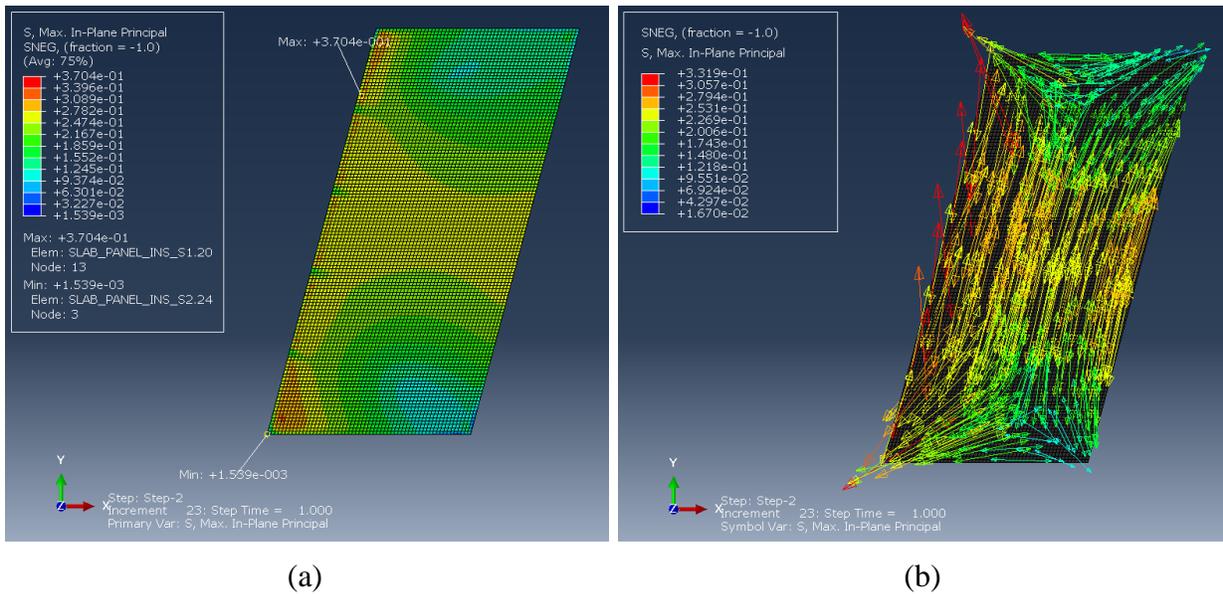
Figure 7.15 Principal stress (ksi) at bottom surface of approach slab with a positive thermal gradient of $+1.26^{\circ}\text{F}/\text{inch}$ ($+0.7^{\circ}\text{C}/\text{inch}$): (a) stress magnitude and (b) stress trajectory.

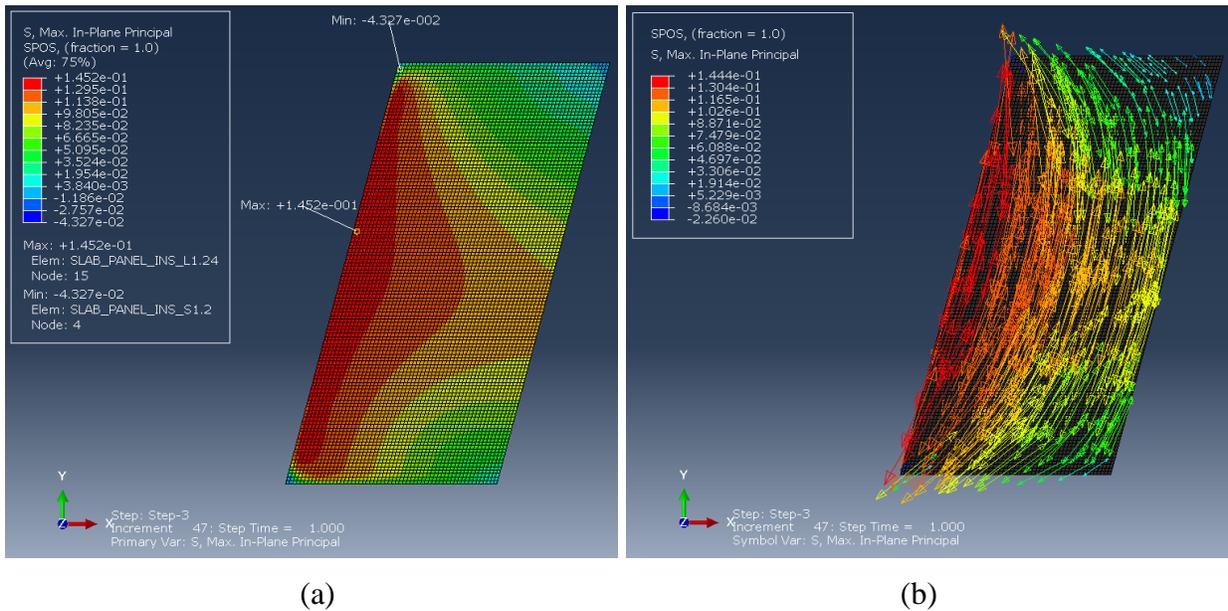
Figure 7.16 Principal stress (ksi) at the top surface of approach slab with a negative thermal gradient of $-0.72^{\circ}\text{F}/\text{inch}$ ($-0.4^{\circ}\text{C}/\text{inch}$): (a) stress magnitude, and (b) stress trajectory.

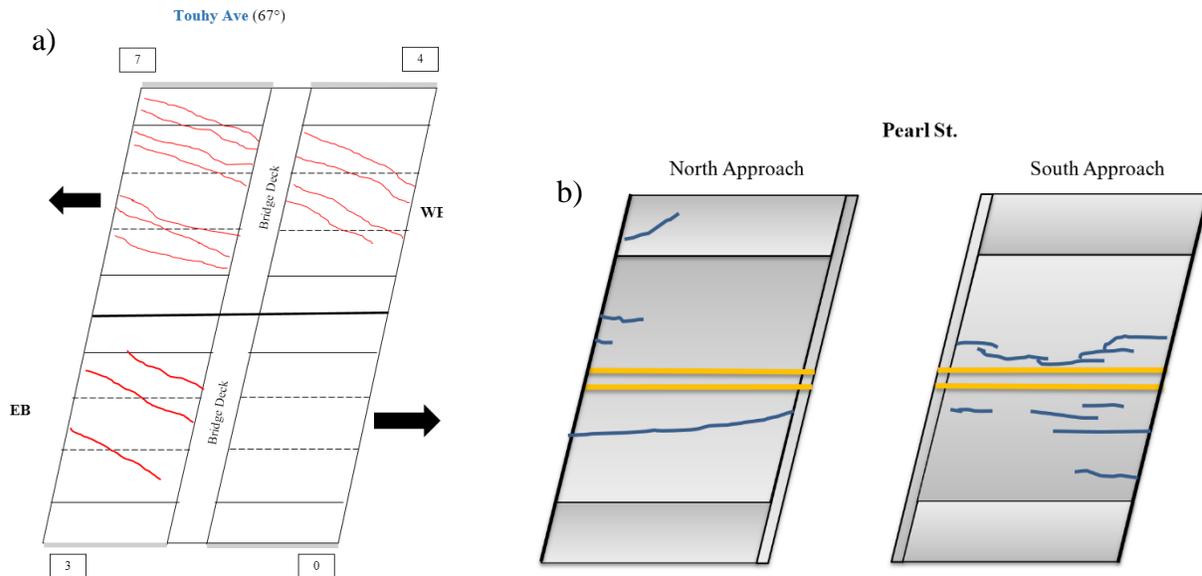
Figure B.1 Crack map of approach slabs from: a) an I-90 Mainline bridge over Touhy Avenue; b) an I-90 Cross Road bridge over Pearl St.

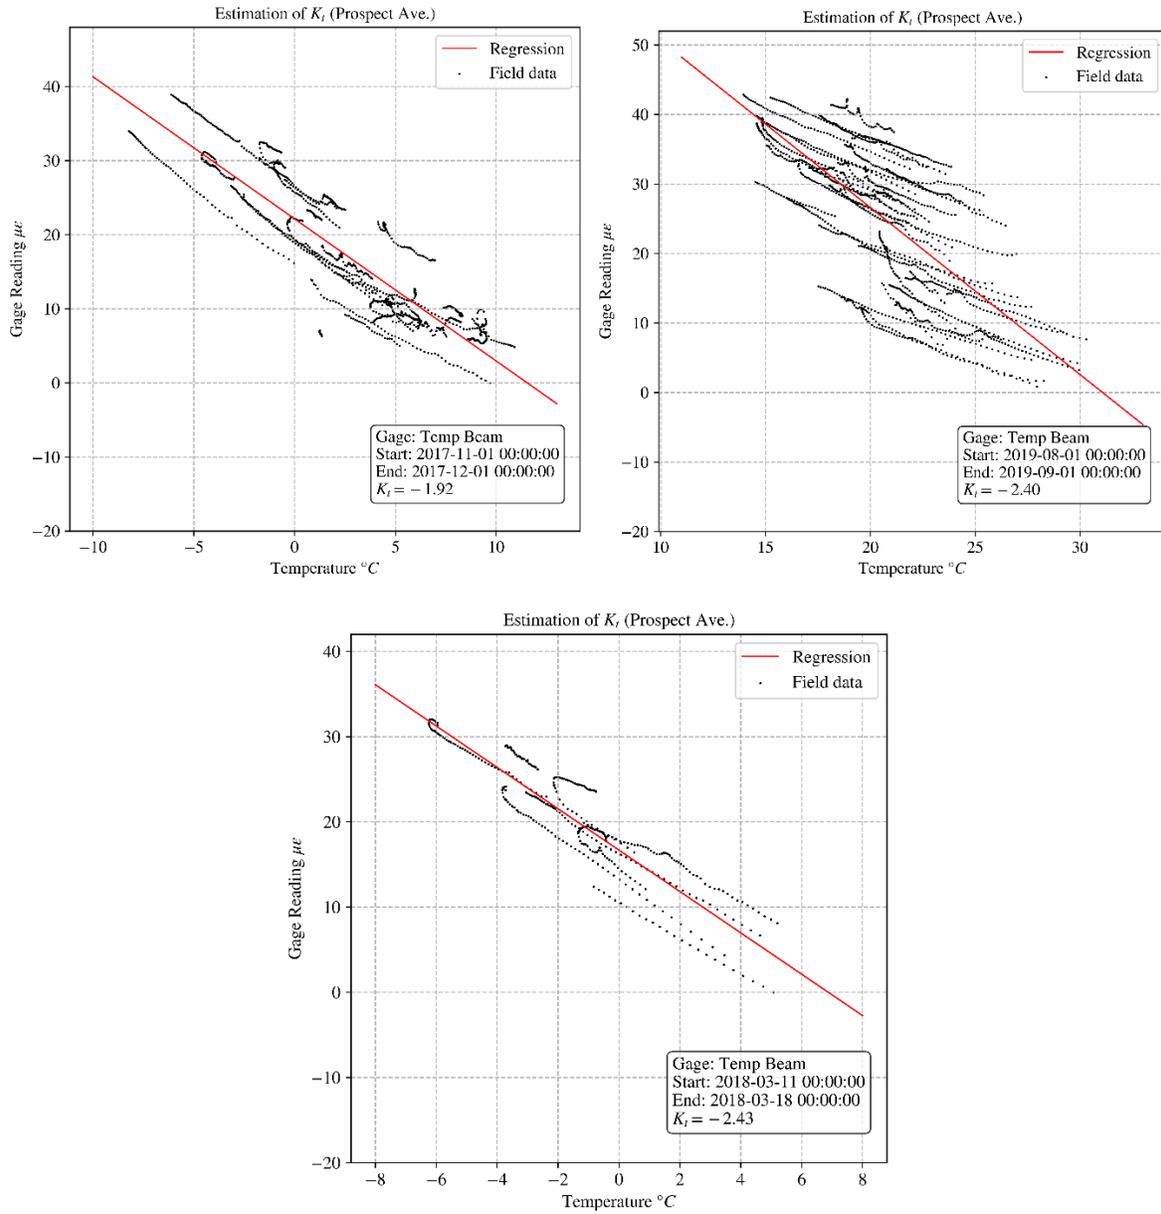
Figure D.1 Examples of monthly data for temperature compensation beam.
